Inspection Report

Property Address:
75 West Amazing Life Steet
Near the Beach NJ 08540

Master Building Inspections

Property Address 75 West Amazing Life Steet Near the Beach NJ 08540	Date of Inspection 3/17/2026	Report ID 202603283341-1930-2300
Customer(s) Susan Green	Time of Inspection 10:30 AM	Real Estate Agent

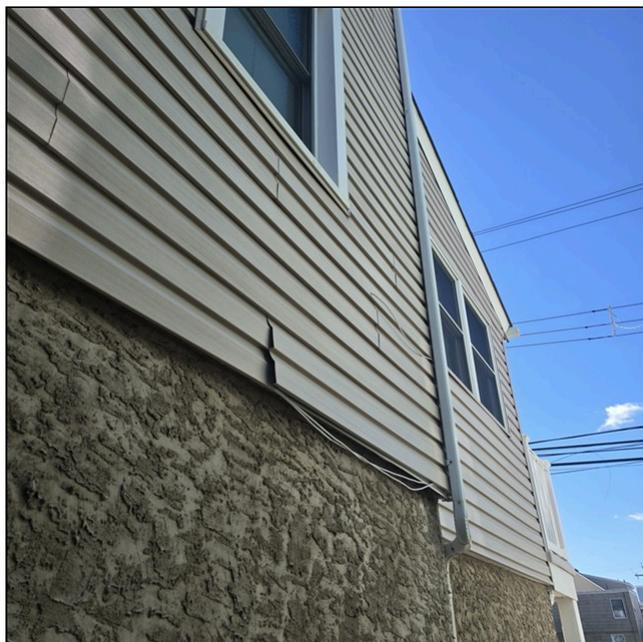
1.0 Item 1 (Picture)

One section of vinyl siding on the side of the home was observed to be loose. Repair as needed to ensure proper attachment and to help prevent moisture intrusion and wind damage.

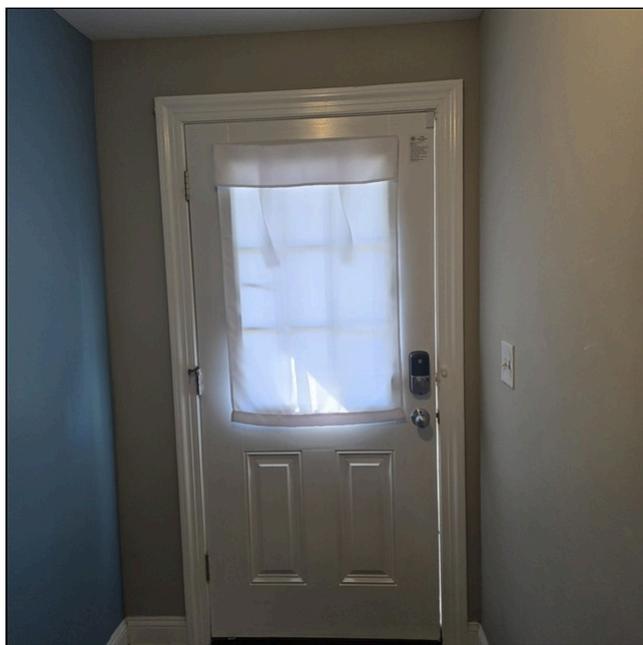
1.1 Item 1 (Picture)

(1) Areas of the front door weatherstripping is damaged and/or missing. This can allow for loss of homes conditioned air increasing electric and gas bills. I recommend having a qualified contractor repair/replace damaged areas

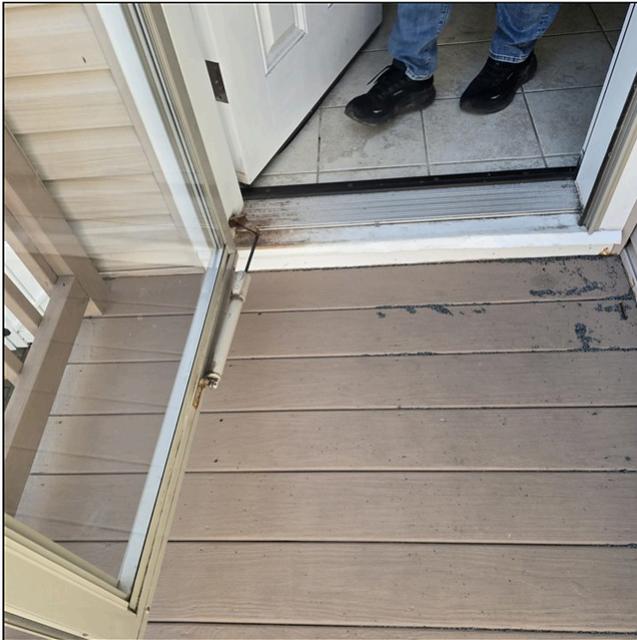
1.1 Item 2 (Picture)

(2) Exterior back door was built at the same level as back deck/patio/porch. This can allow rain or overflow from gutters to penetrate door jam area causing damage to framing below. It is recommended to have a 4 inch step up from exterior doors to prevent this issue. This is not possible with out rebuilding the deck/patio/porch. I recommend further evaluation to determine if the flashing is present. If no flashing is present, have the contactor install a proper flashing or water sealant under at bottom door jam/transition can be sufficient.

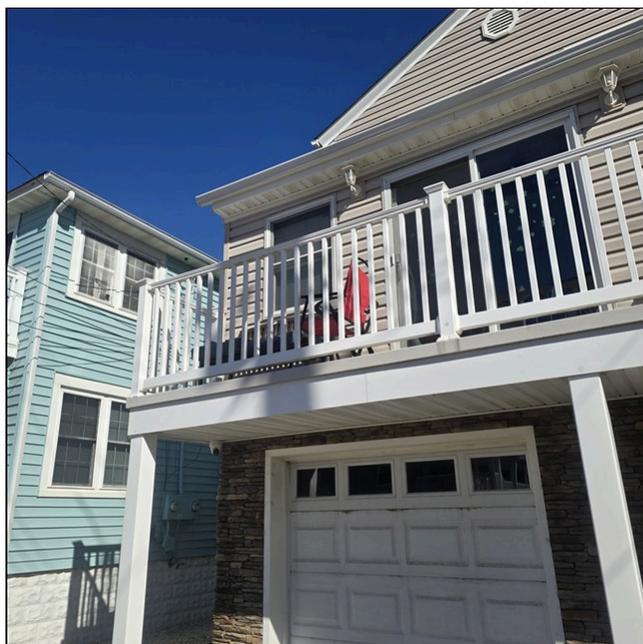
1.3 Item 1 (Picture)

(1) The front deck over the front entry door had finished materials in place, which obstructed the view of the underlying framing. The walking surface consisted of a painted fiberglass system and was observed to be in good condition at the time of inspection.

Given the coastal environment, this type of surface is subject to increased wear from salt air, moisture, and UV exposure. Routine maintenance, including periodic cleaning, inspection for cracks or coating failure, and recoating as needed, is recommended to maintain performance and prevent water intrusion.

Similar fiberglass deck systems typically have an estimated serviceable life of approximately 10 to 20 years, depending on installation quality and ongoing maintenance.

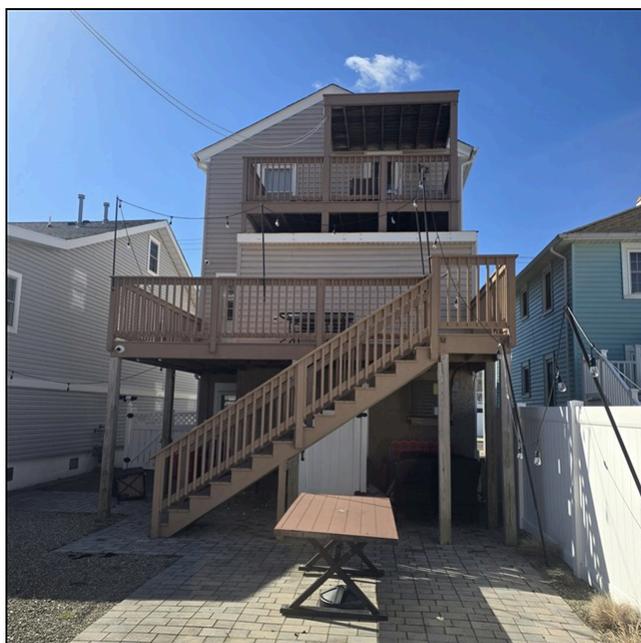
1.3 Item 7 (Picture)

(2) The home has an elevated rear deck with stairs from the ground. The deck was observed to be in fair condition. The stairs have open risers; use caution. Mechanical connections exhibited some corrosion at fasteners, indicating age and exposure. Recommend maintenance and repairs as needed to help prolong the life of the deck.

One concern was noted with the deck framing. The floor boards are secured at the center of the deck to doubled floor joists, with a connection occurring between the ledger board and rim board within the deck plane. This configuration suggests that a portion of the deck load may be transferred through interior framing members rather than being fully supported at the ledger and outer beam as typically expected. This is an unconventional load path.

Recommend checking for permits and having the deck framing further evaluated to confirm proper structural design and support.

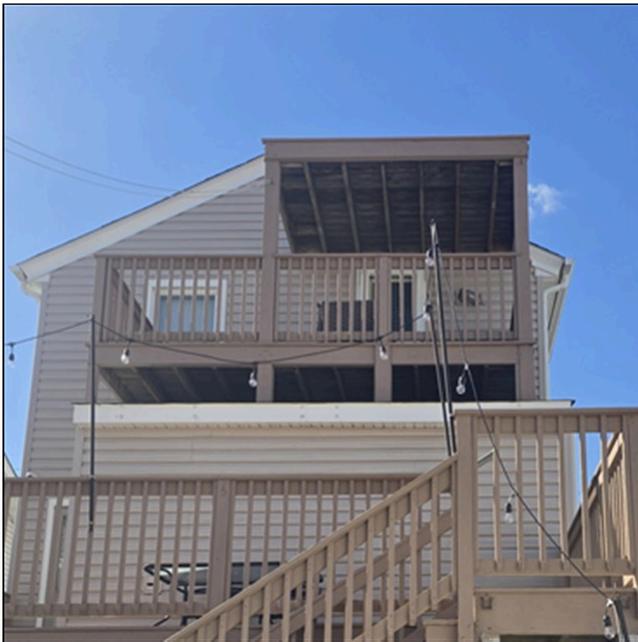
1.3 Item 14 (Picture)

(3) An additional elevated deck was observed above the rear deck, located over a roof surface. Safe access was not available. This deck appears to be installed over an asphalt shingle roofing surface and also supports a roof deck above.

The deck was observed to be in poor condition. Mechanical connections were rusted and deteriorated, and the walking surface and associated roofing materials were in poor condition.

The client provided an aerial image of the home showing that the structure previously consisted of a deck over a roof surface with an additional higher deck above it. The highest section has since been removed; however, portions remain, including deck boards that are now acting as a roof surface to some degree. This configuration is improper and increases the risk of water intrusion and structural concerns.

This condition is unsafe. Recommend removal or full replacement of this deck.

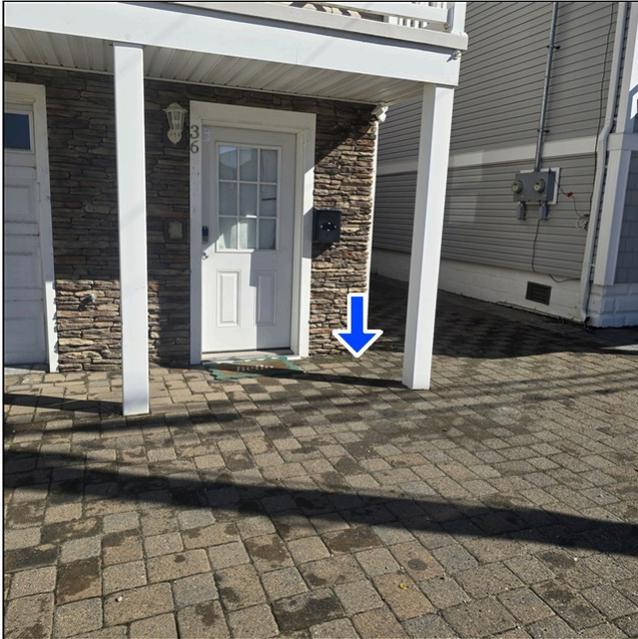
1.4 Item 1 (Picture) low spot.

(2) The exterior of the home consists of stone to allow for drainage, with paver surfaces at the front and side of the dwelling. The pavers at the front corner adjacent to the entry door were observed to have improper pitch. This condition may allow water to accumulate in this area. It had rained the night prior to the inspection; however, no standing water was observed at that time.

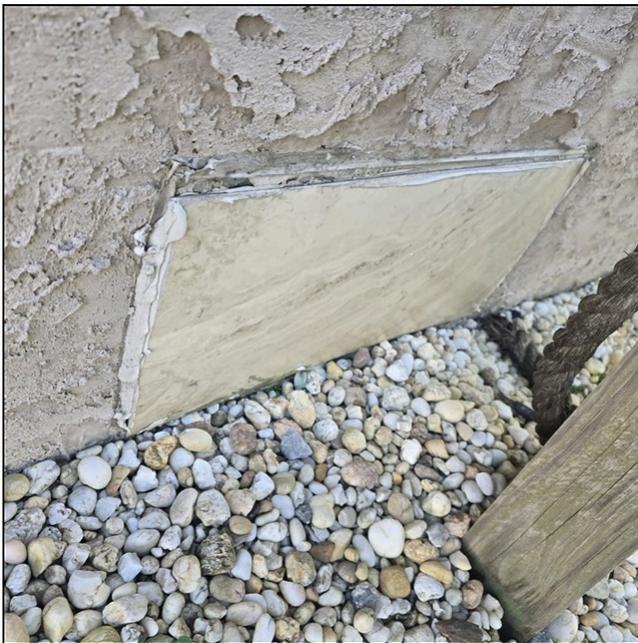
1.4 Item 2 (Picture)

These openings are often subject to FEMA flood vent requirements. The inspector is not familiar with specific FEMA compliance requirements. Recommend further evaluation and confirmation that the installation meets applicable FEMA requirements, and optimize the number, placement, and condition of these vents/drains as needed.

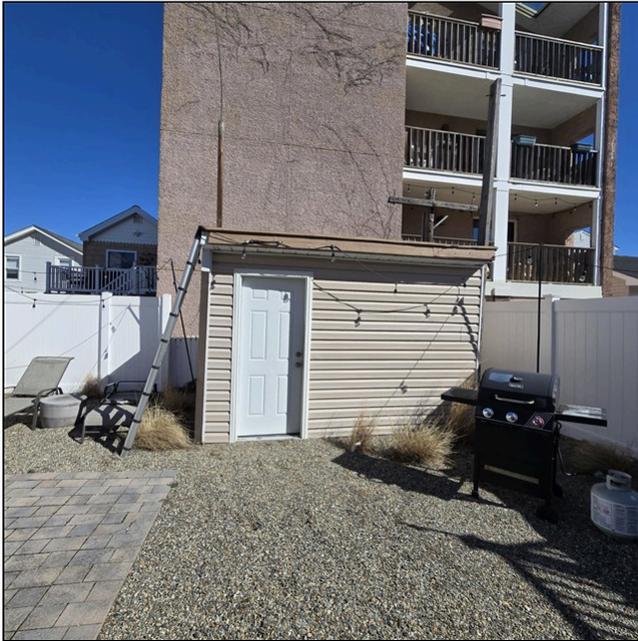
1.6 Item 1 (Picture)

The shed was observed to be in poor condition. The rolled roofing material was worn, and the exterior cladding showed deterioration. The interior framing was obstructed by installed OSB panels, limiting inspection. The shed appears to be built directly on grade. Recommend repairs or replacement as needed.

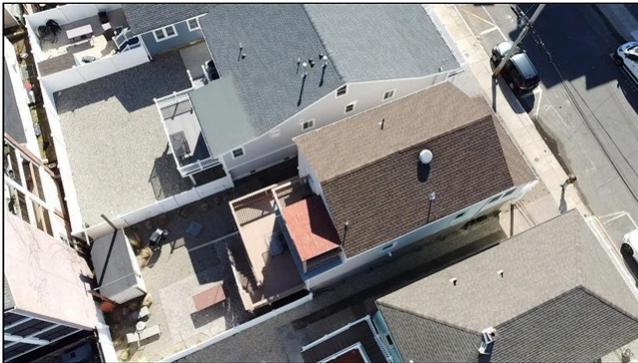
2.0 Item 1 (Picture)

The roofing surfaces over the front balcony and beneath the upper rear deck were observed to be older, with evidence of damage, exposed fiberglass, and active leaking in one or more locations. Recommend replacement of these smaller roofing sections. The rear deck will need to be removed to properly address the roofing beneath.

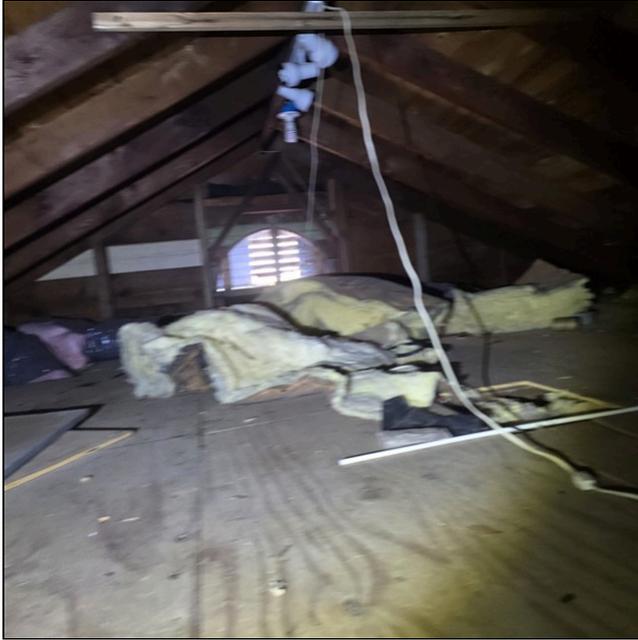
3.0 Item 1 (Picture)

The attic was floored over, which obstructed the view of most to all insulation. This limited evaluation of insulation levels and condition. Further evaluation is recommended as a precaution. Inadequate or unknown insulation may contribute to increased energy costs.

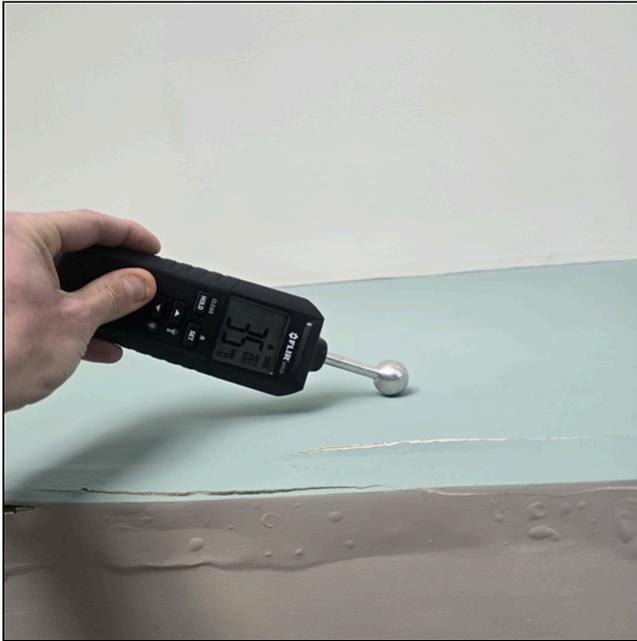
5.0 Item 1 (Picture)

An active leak was observed at the second-floor front section of the home. The headwall flashing appears to be failing, and the roof is older. Moisture testing with a non-destructive meter indicated elevated readings consistent with saturation. Concealed damage should be expected. Recommend further evaluation and repair as needed.

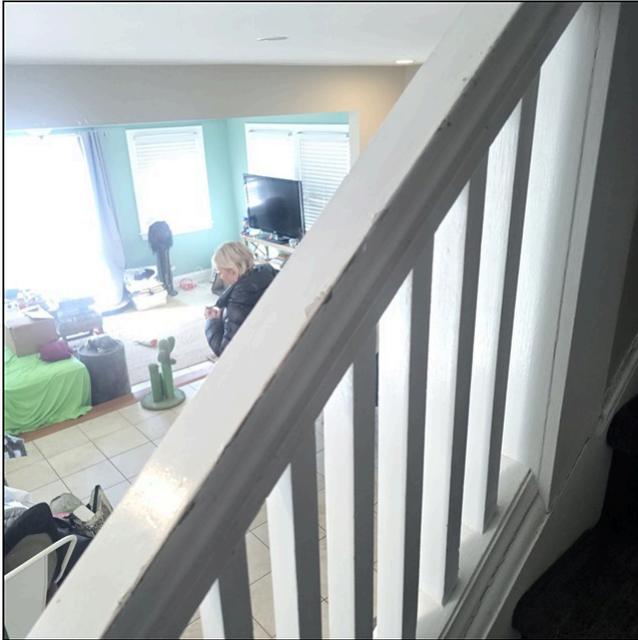
5.2 Item 1 (Picture)

(1) Interior painted surfaces may contain lead due to the age of the home.

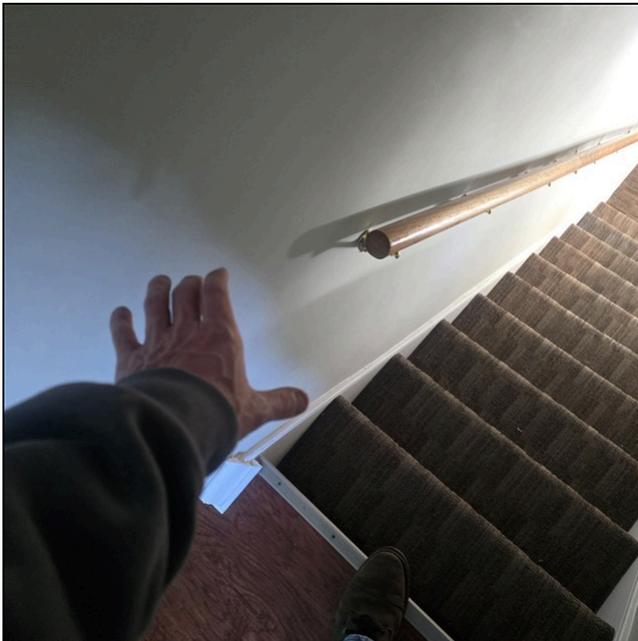
5.2 Item 2 (Picture)

(2) The handrail does not fully extend to the top floor, creating a safety hazard. Extend or modify the handrail to provide continuous support.

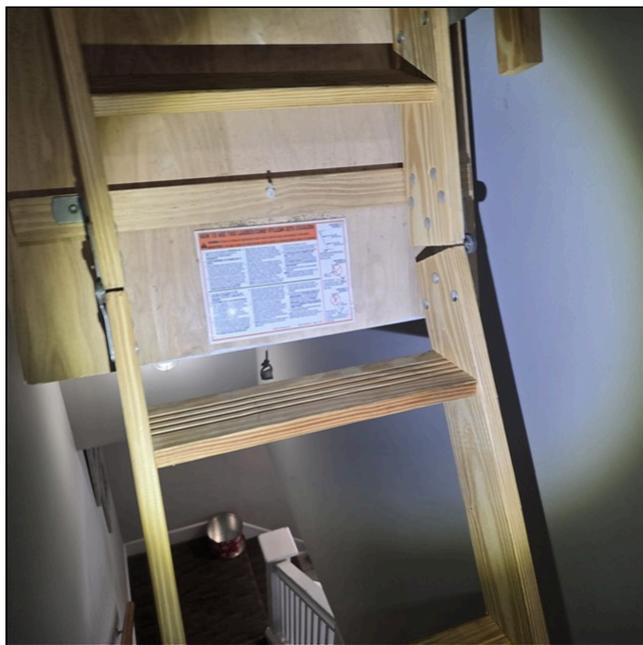
5.4 Item 1 (Picture)

(1) The pull-down attic stairs were overextended, creating a potentially unsafe condition. Repair or adjustment is recommended to ensure proper operation and safe use.

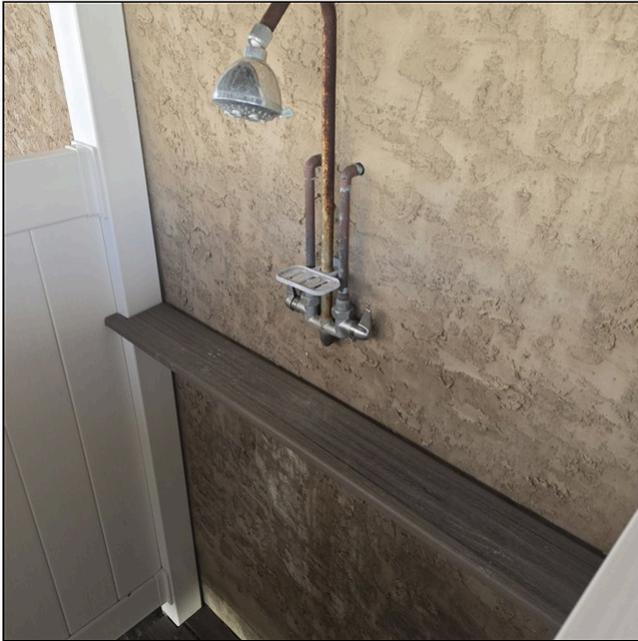
6.0 Item 1 (Picture)

(1) An exterior shower was present and appeared to be winterized at the time of inspection. The utility room in the basement was locked, and the internal plumbing components associated with this system were not inspected. Recommend further evaluation prior to purchase to confirm proper condition and to ensure no defects are present.

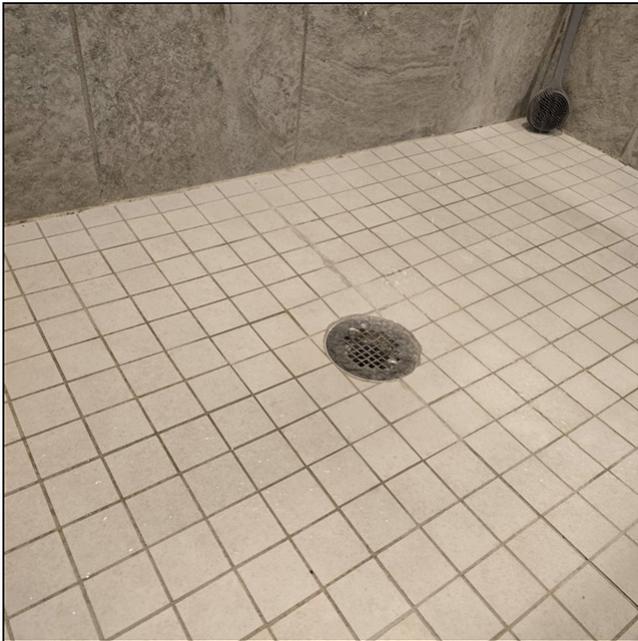
6.0 Item 2 (Picture)

(2) The shower pan had a line of sealant applied along a mortar joint, indicating a past repair. The utility room below was locked, which limited evaluation of this area. Further evaluation is recommended to ensure there are no active leaks or concealed damage.

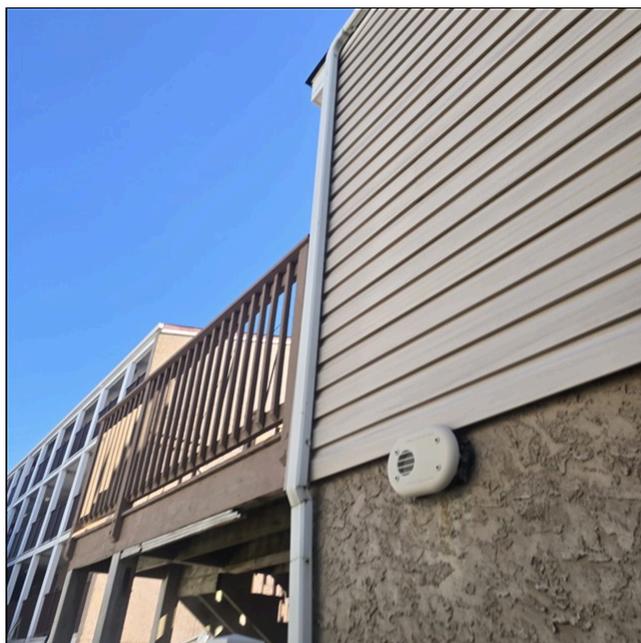
6.2 Item 1 (Picture)

Recommend having the water heater made accessible and fully evaluated prior to purchase to determine its age, condition, and any defects. Failure to do so may result in unexpected repair or replacement costs.

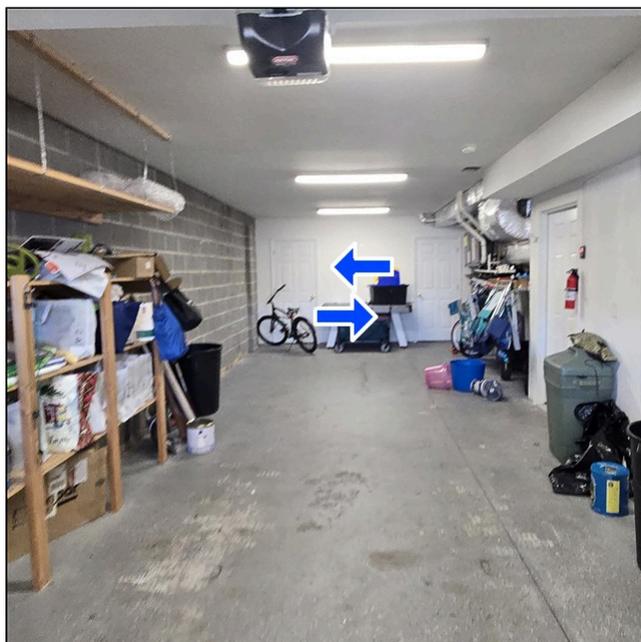
6.8 Item 1 (Picture)

Plumbing components, including the waste piping, main water shut-off, and water heater, were not observed as the utility closets in the garage were locked. Failure to have these areas inspected prior to purchase may result in significant unexpected expenses. Recommend gaining access and having these areas fully inspected prior to purchase.

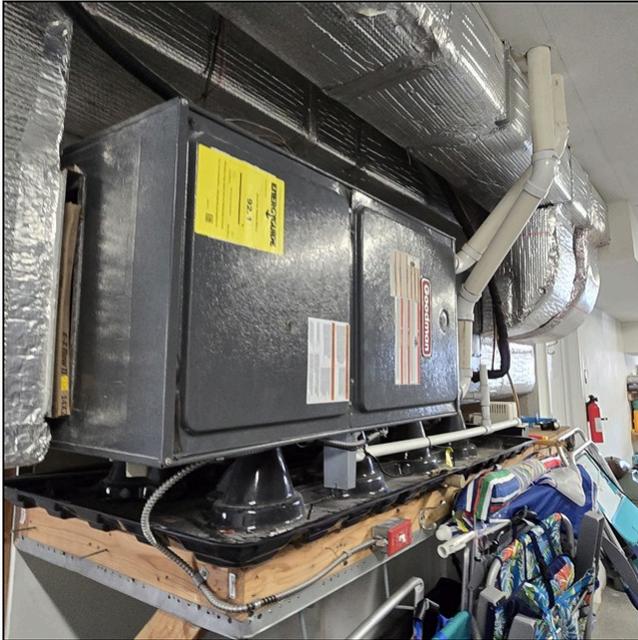
7.0 Item 1 (Picture)

The system is in need of servicing. As a precaution, the heat exchanger should be evaluated. Similar furnaces typically have an estimated serviceable life of approximately 15 to 20 years under normal conditions. In coastal environments, the serviceable life is often reduced due to exposure to moisture and salt air. Based on the observed condition and age, budget for replacement.

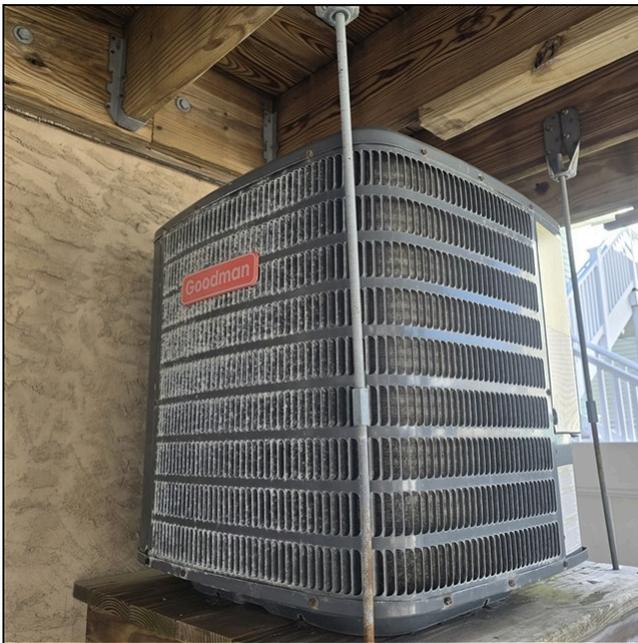
7.5 Item 1 (Picture)

In coastal environments, air conditioning equipment is subject to accelerated deterioration due to salt air and moisture. Similar systems in these conditions typically have a reduced serviceable life compared to inland units. Routine maintenance, including regular cleaning, coil rinsing, and protective coatings, can help prolong equipment life. Equipment specifically designed for coastal or high-corrosion environments may also be considered for improved durability.

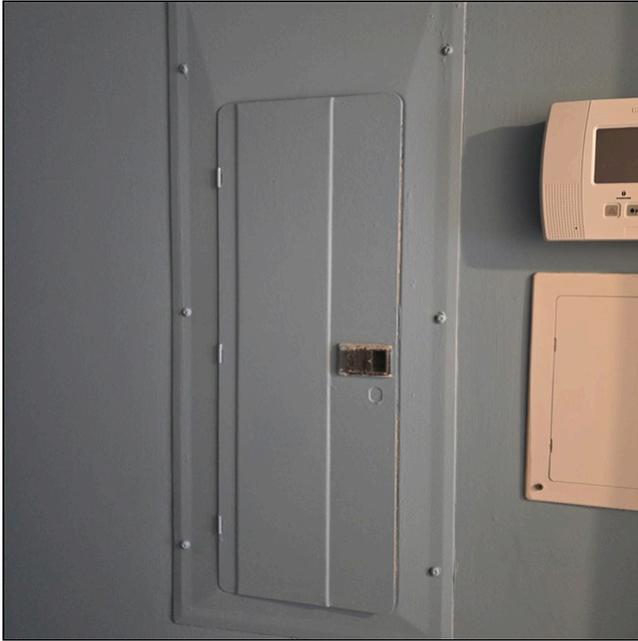
8.1 Item 1 (Picture)

(3) The main 200 amp electrical panel was located in the first-floor hallway. The panel was observed to be in good condition at the time of inspection.

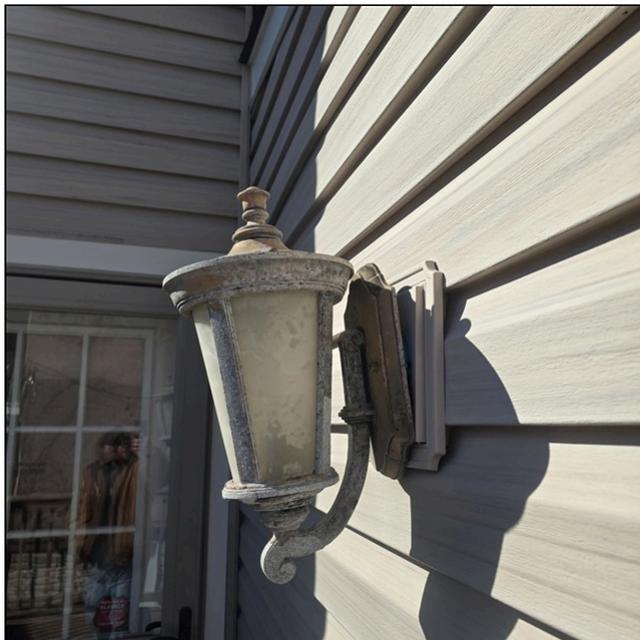
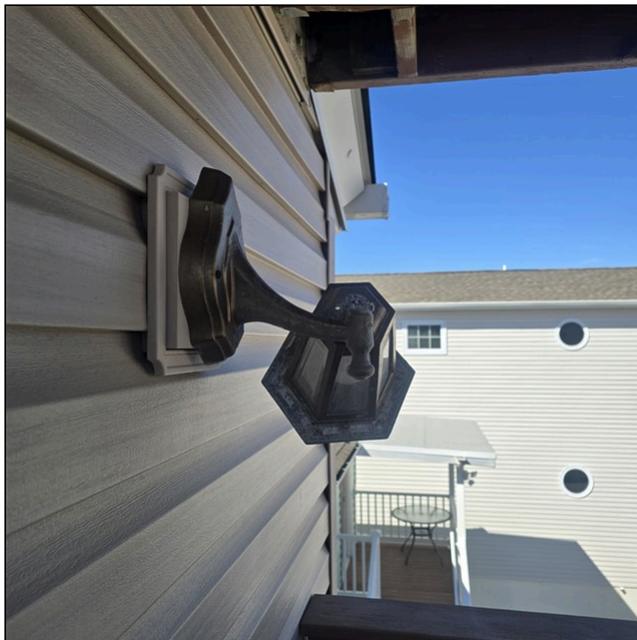
(1) Two exterior light fixtures were observed to be loose and hanging from the wall. Repair or secure as needed to ensure proper mounting and safe operation.

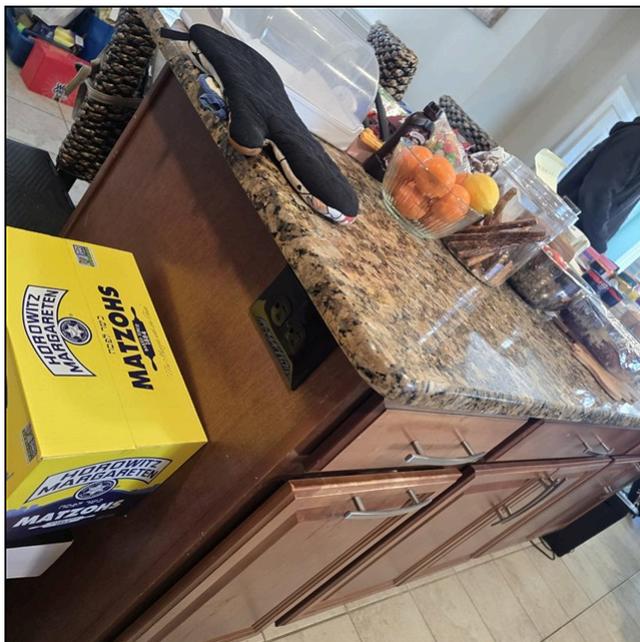
8.3 Item 3 (Picture)

(2) There is an outlet on the side of the kitchen island. A child can pull a wire plugged into this location and be injured. I recommend not using this plug and or removal of the plug.

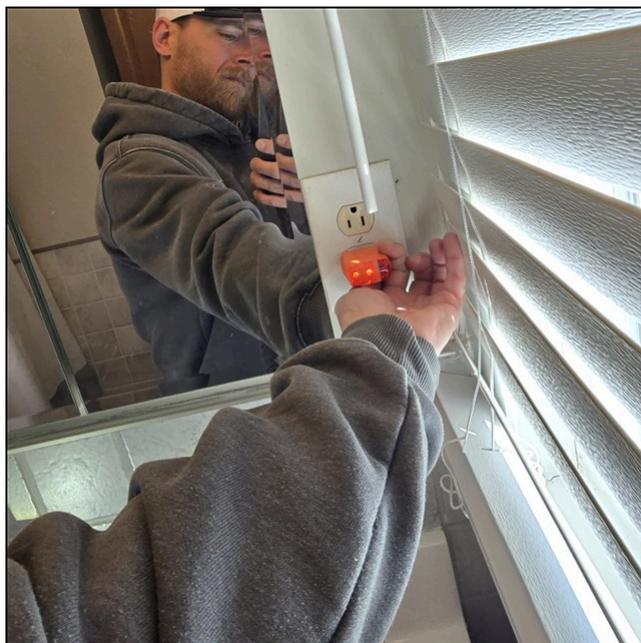
8.4 Item 1 (Picture) upstairs bathroom.

people from electrical shocks. It works by monitoring the flow of electrical current through a circuit, and it can detect when there is an imbalance in the current, which can be caused by a ground fault. When a ground fault is detected, the GFCI quickly shuts off the power to the circuit to prevent electrical shock.

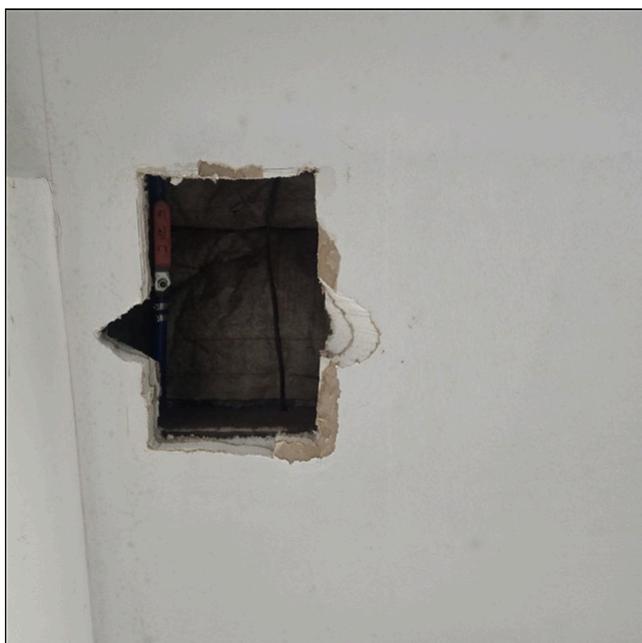
10.1 Item 1 (Picture)

Some areas were observed where fire could potentially travel from the garage to the living space. Recommend fireproofing these sections as a precaution to improve separation and safety.

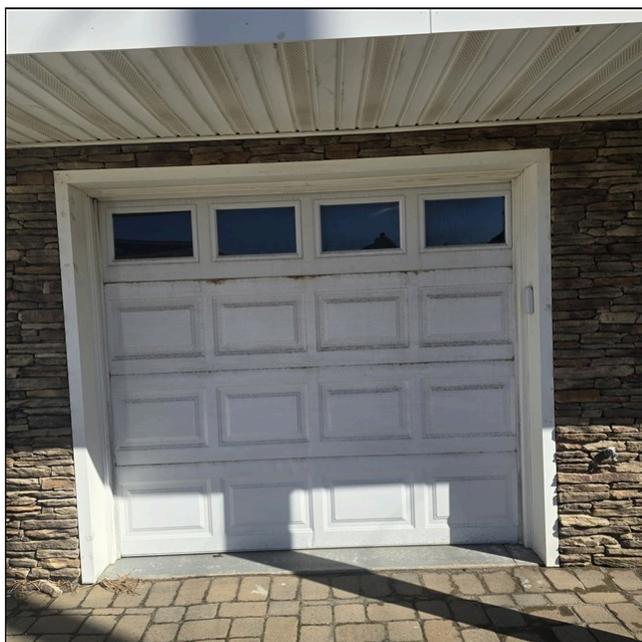
10.7 Item 1 (Picture)

The metal garage door exhibited areas of rust and corrosion. Flaking paint was also observed and may contain lead. Have the door further evaluated and repainted to help prevent further deterioration and prolong its serviceable life. Use caution when disturbing painted surfaces.
