Inspection Report

Property Address:
75 West Amazing Life Steet
Near the Beach NJ 08540

Master Building Inspections

Property Address 75 West Amazing Life Steet Near the Beach NJ 08540	Date of Inspection 3/17/2026	Report ID 202603283341-1930-2300
Customer(s) Susan Green	Time of Inspection 10:30 AM	Real Estate Agent

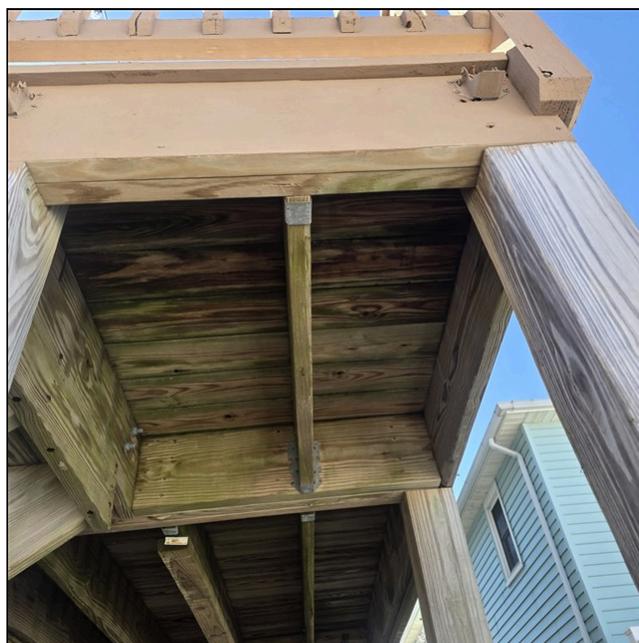
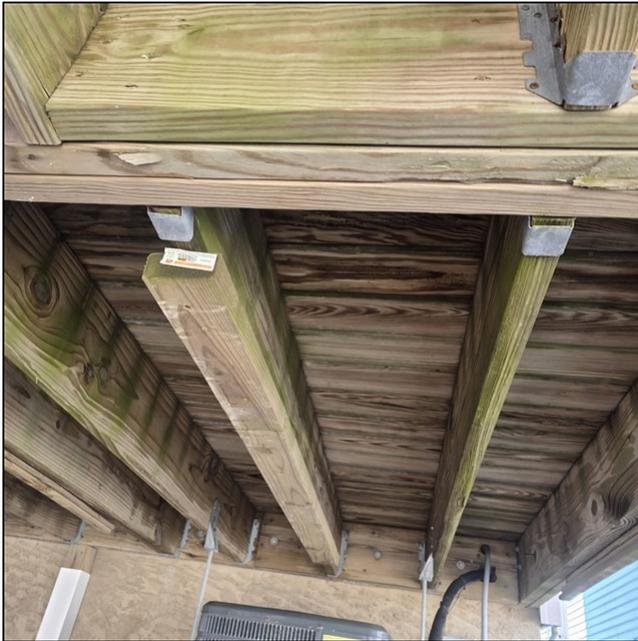
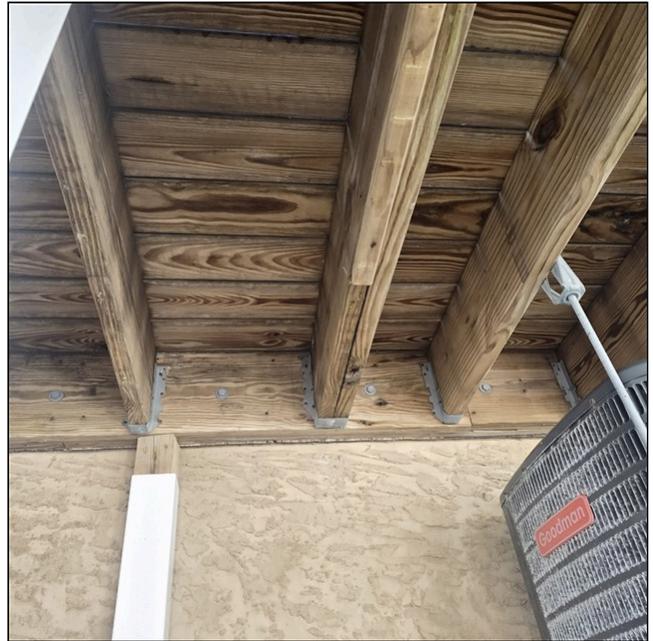
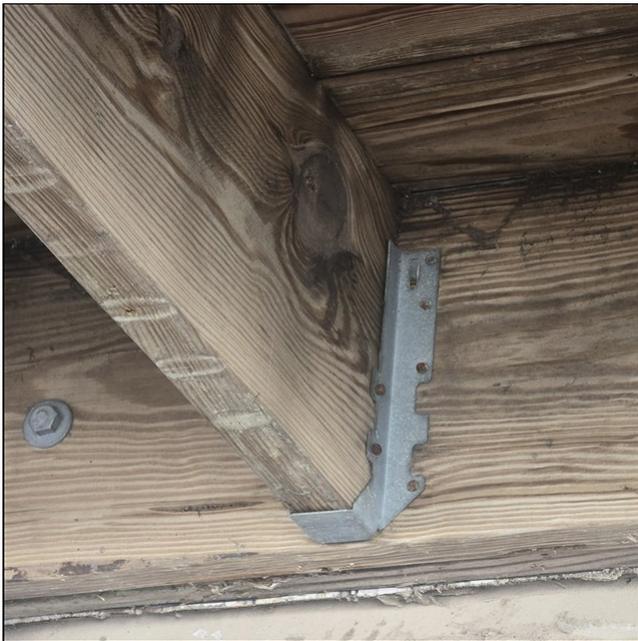
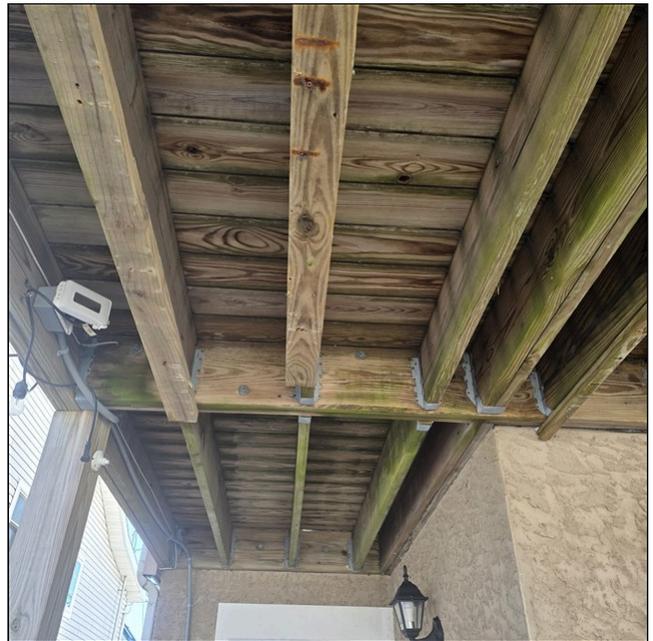
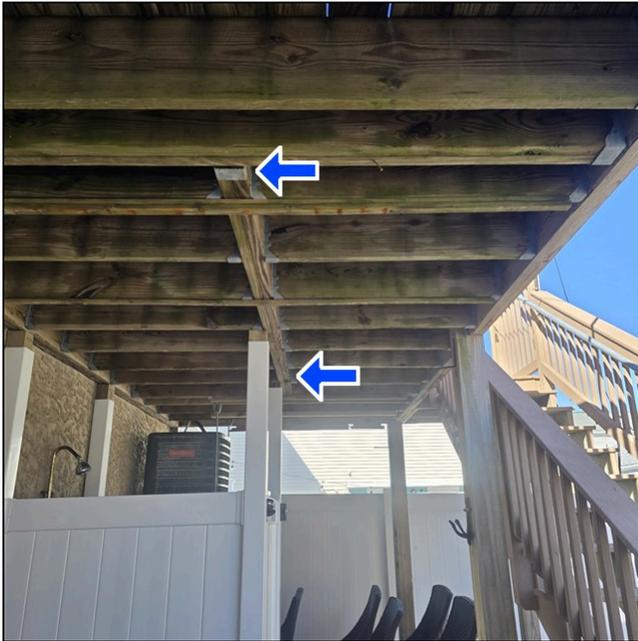
(3) An additional elevated deck was observed above the rear deck, located over a roof surface. Safe access was not available. This deck appears to be installed over an asphalt shingle roofing surface and also supports a roof deck above.

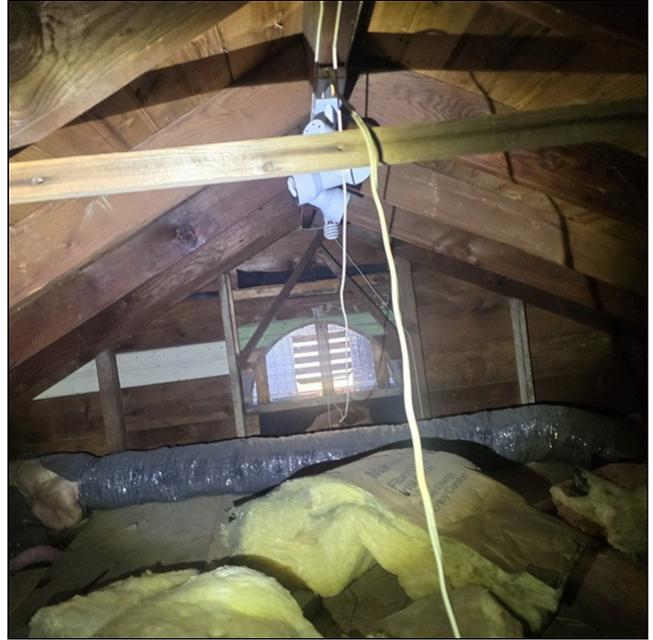
3.0 Item 2 (Picture)

The attic was floored over, which obstructed the view of most to all insulation. This limited evaluation of insulation levels and condition. Further evaluation is recommended as a precaution. Inadequate or unknown insulation may contribute to increased energy costs.

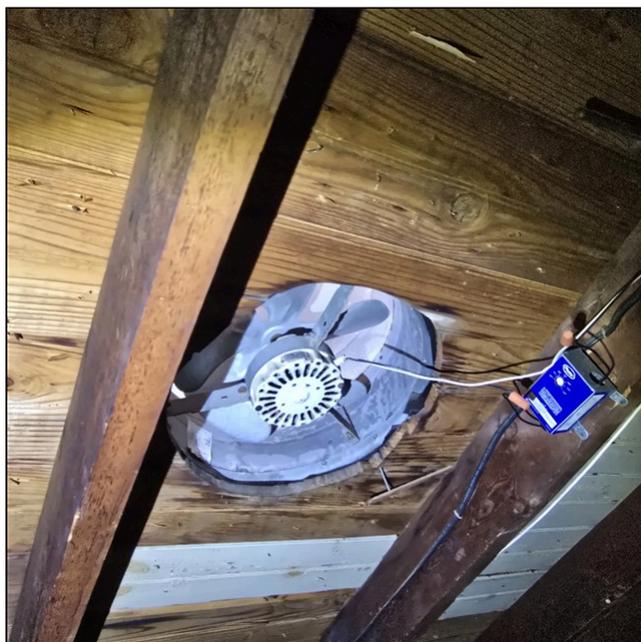
3.3 Item 1 (Picture)

The attic fan was not tested as the temperature was too cool to initiate the fan. I suggest making the sure the fan is operational and safe when the exterior temperature is much warmer. The fans purpose is to aid in venting the hot attic air during warmer months. This helps the roof surface cooler which prolongs the life of the roof.

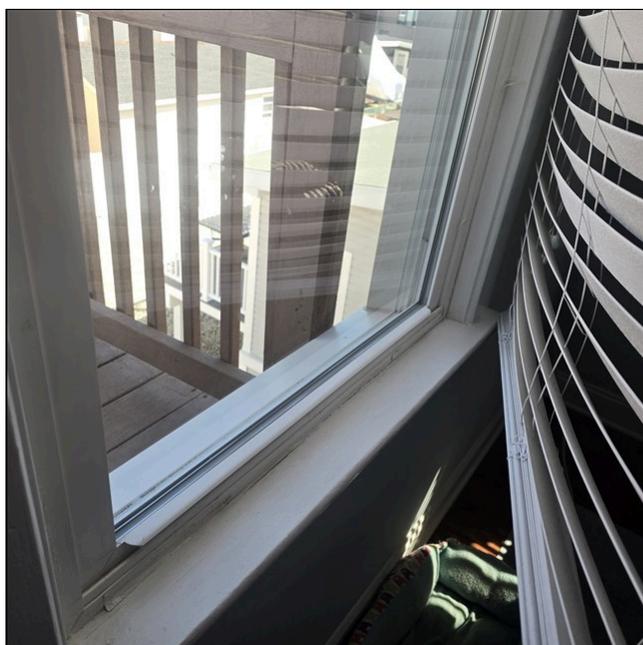
5.5 Item 1 (Picture)

Comments: Inspected
The windows were in good condition.

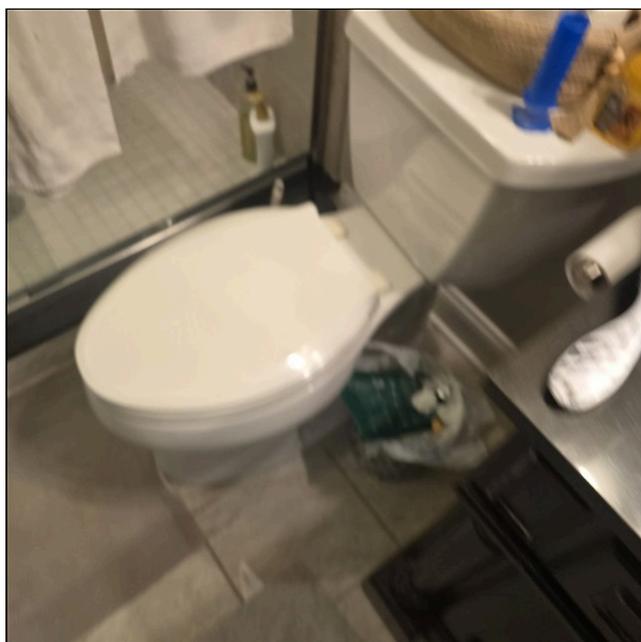
6.1 Item 1 (Picture)

(2) The toilet base is loose in the room(s) in the photographs below. A loose toilet can have several implications, including: Water leaks: If the toilet is not securely anchored to the floor, it can cause water to leak around the base of the toilet. This can cause damage to the surrounding flooring and even lead to mold growth. Unpleasant odors: If the toilet is not tightly sealed to the drainpipe, sewer gases can escape and cause unpleasant odors in the bathroom. Structural damage: A loose toilet can eventually cause damage to the surrounding flooring and subflooring. If left unrepaired, this can lead to costly repairs. Safety hazards: A wobbly toilet can be a safety hazard, especially for children or the elderly, who may be at risk of falling or slipping. Inefficient flushing: A loose toilet can result in inefficient flushing, which can lead to clogs and require more frequent cleaning. It is important to address a loose toilet promptly to prevent these potential problems and ensure the safety and functionality of your bathroom.

I recommend further evaluation to ensure no concealed damage is present. I recommend repairs as needed by a licensed professional.

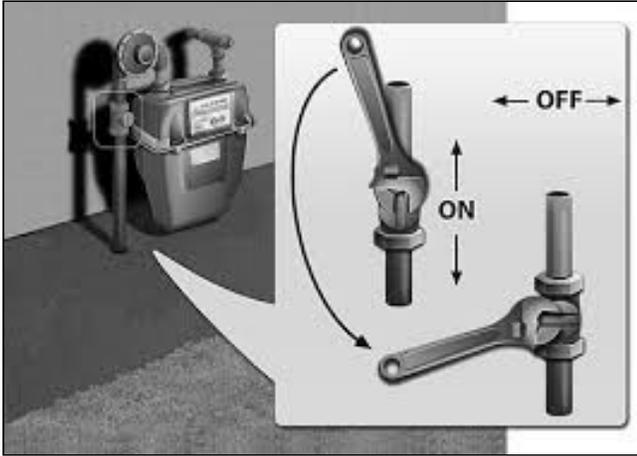
6.5 Item 1 (Picture)

The main gas shutoff valve is located next to the meter on the exterior of the house and is operated with a wrench in case of an emergency. This is for your information.

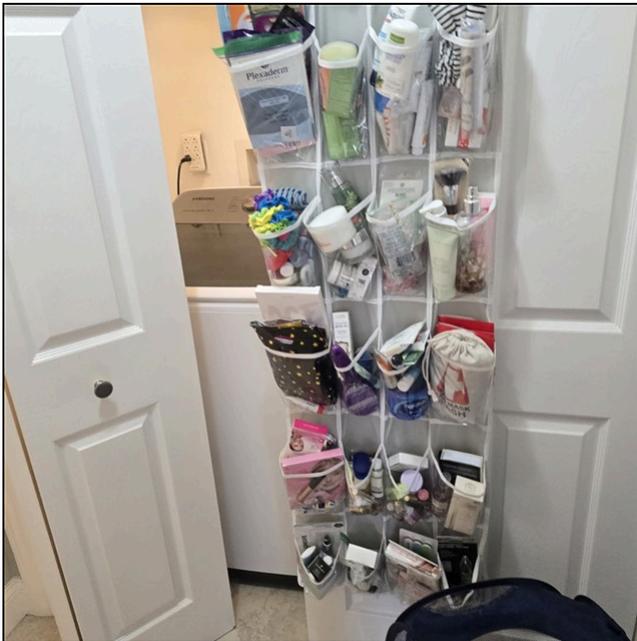
6.7 Item 1 (Picture)

Both clothes washer and dryer were present and operational during the time of inspection.

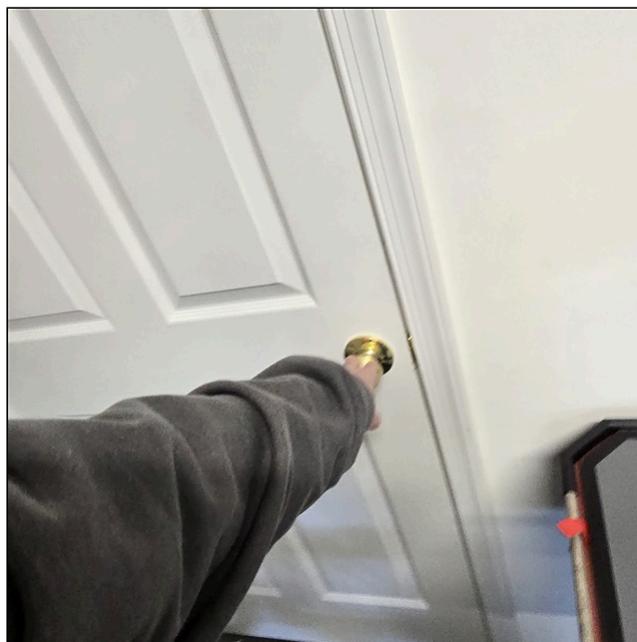
Plumbing components, including the waste piping, main water shut-off, and water heater, were not observed as the utility closets in the garage were locked. Failure to have these areas inspected prior to purchase may result in significant unexpected expenses. Recommend gaining access and having these areas fully inspected prior to purchase.

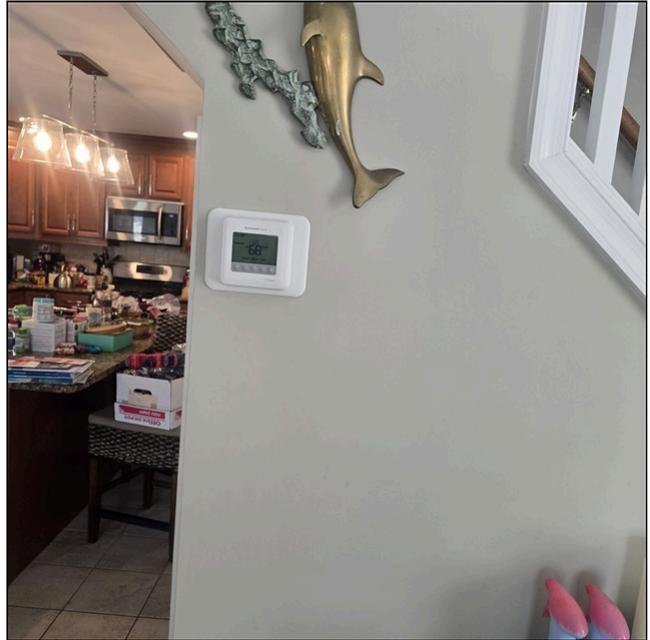
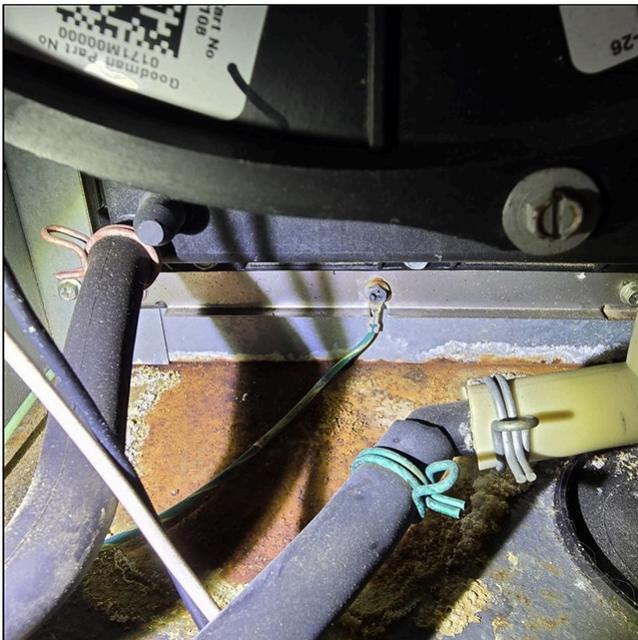
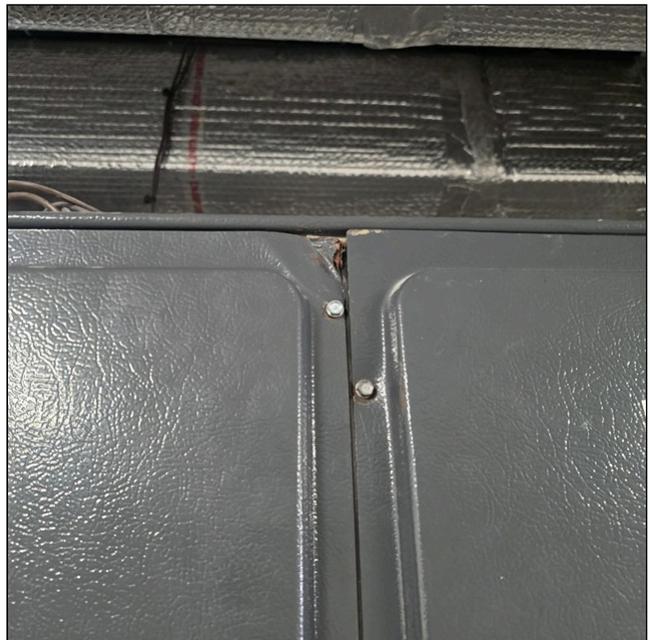
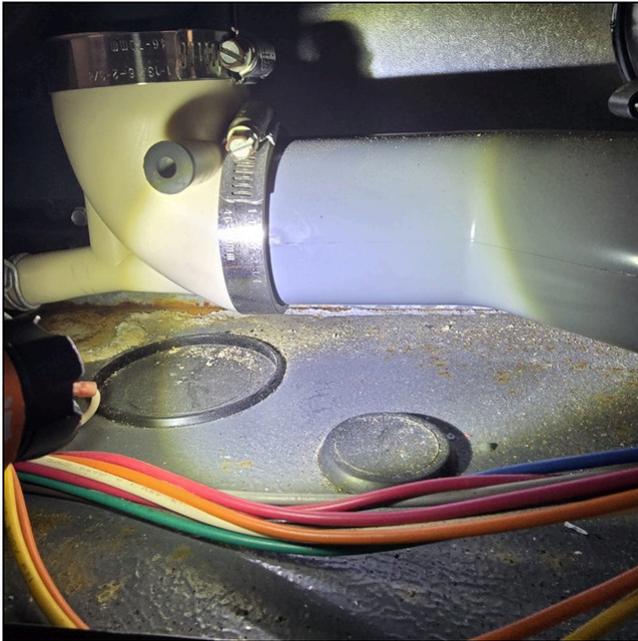
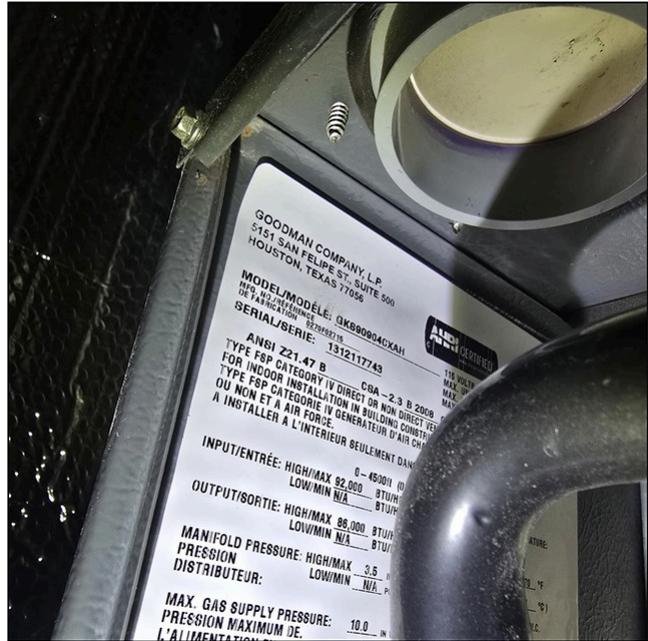
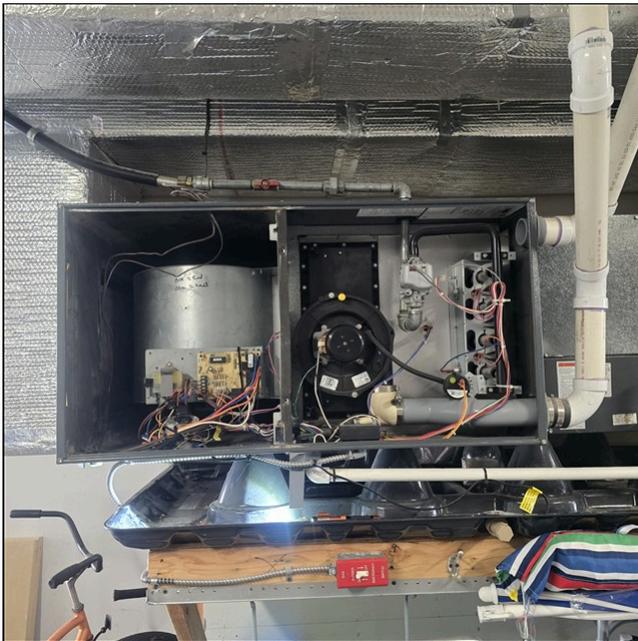
The furnace was manufactured in 2013 and is located in the garage in an elevated position. Evidence of rust and corrosion was observed. Corrosion was noted beneath the vent connection, indicating a need for service.

The system is in need of servicing. As a precaution, the heat exchanger should be evaluated. Similar furnaces typically have an estimated serviceable life of approximately 15 to 20 years under normal conditions. In coastal environments, the serviceable life is often reduced due to exposure to moisture and salt air. Based on the observed condition and age, budget for replacement.

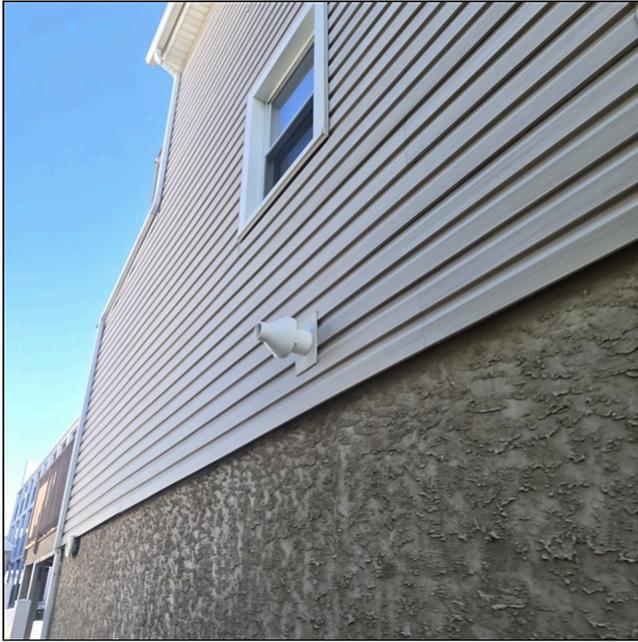
7.3 Item 1 (Picture)

The side wall vent for the high-efficiency furnace terminates on the side of the home below a window. Clearance appeared acceptable at the time of inspection; however, use caution, as exhaust gases and

moisture may impact the adjacent window area.

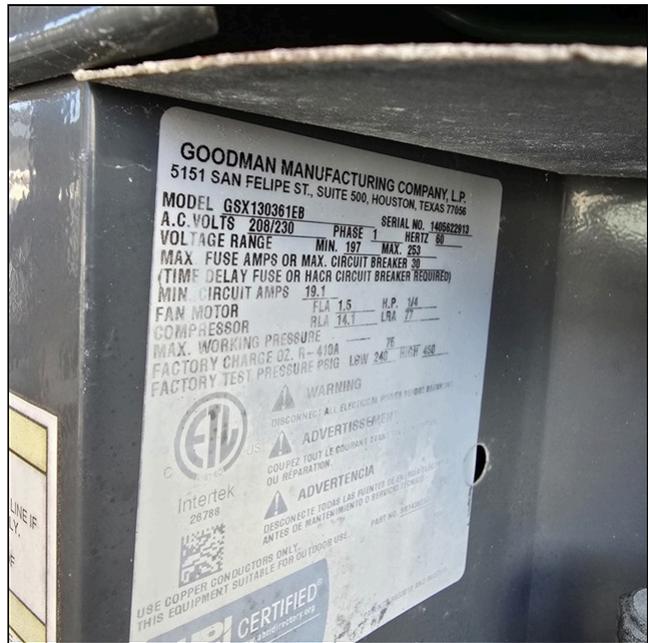
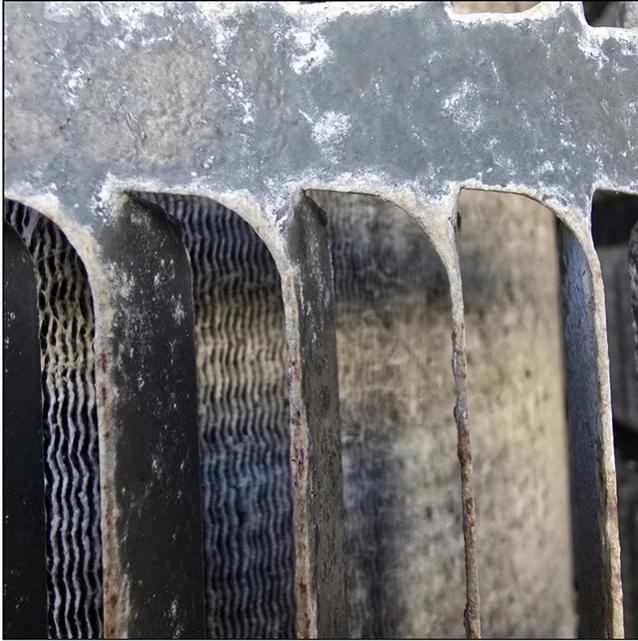
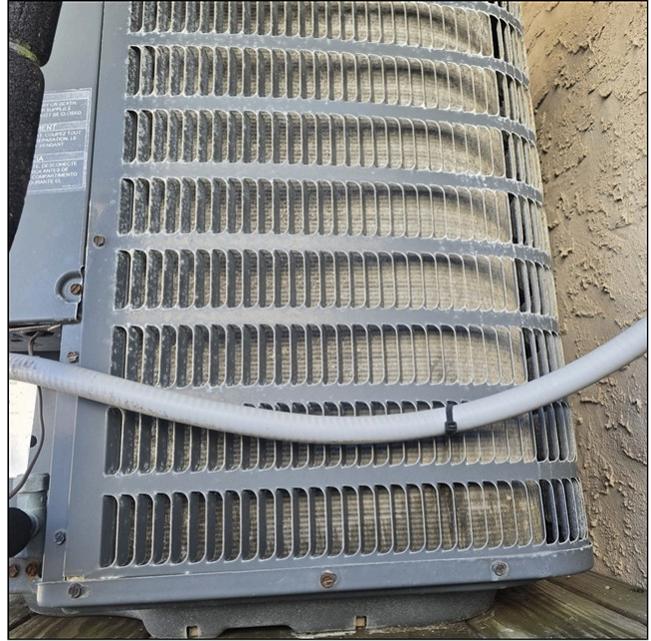
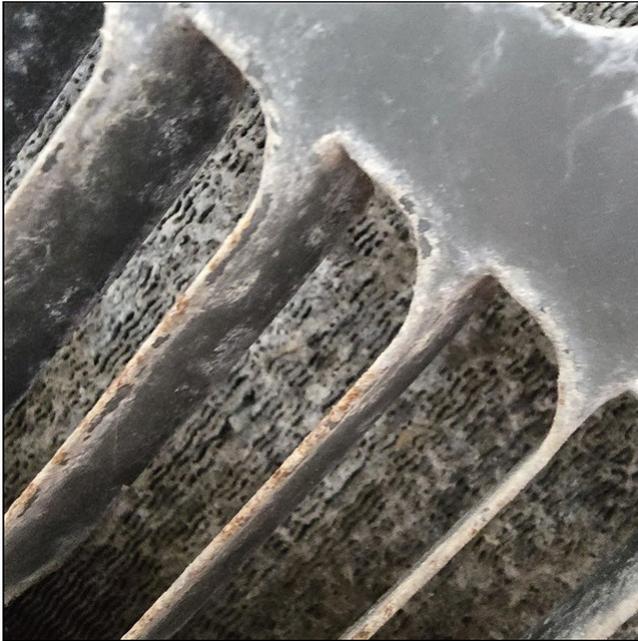
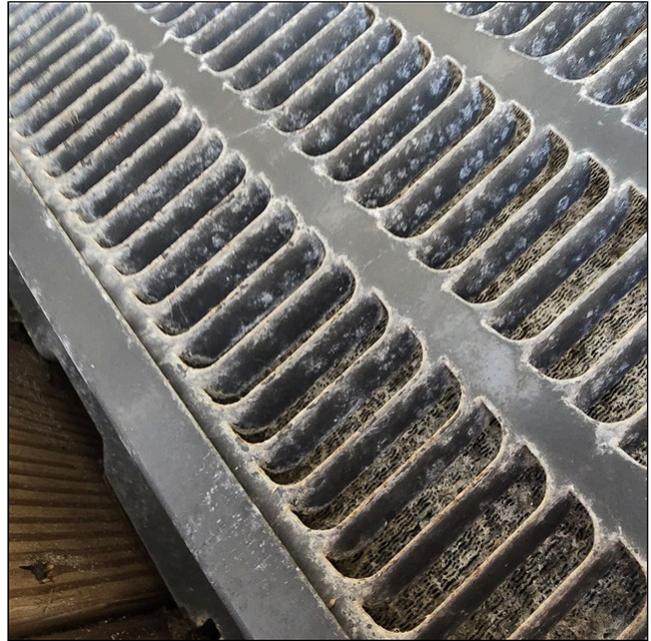
The air conditioning condenser was manufactured in 2014 and was observed to be in poor condition. Significant corrosion was present, consistent with prolonged exposure to a coastal environment. The system was not tested due to outdoor temperatures being below 65 degrees at the time of inspection. Window air conditioning units were observed serving the upstairs bedrooms.

In coastal environments, air conditioning equipment is subject to accelerated deterioration due to salt air and moisture. Similar systems in these conditions typically have a reduced serviceable life compared to inland units. Routine maintenance, including regular cleaning, coil rinsing, and protective coatings, can help prolong equipment life. Equipment specifically designed for coastal or high-corrosion environments may also be considered for improved durability.

Based on the observed condition, the main system may require immediate replacement. Budget for replacement is recommended.

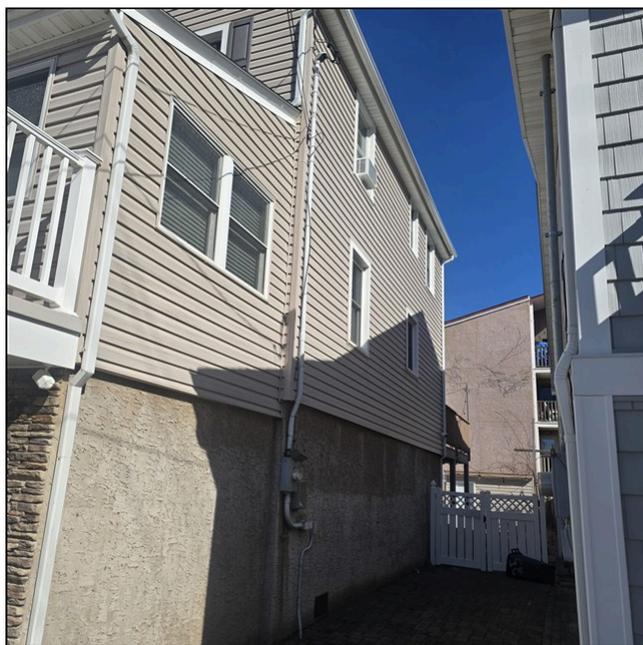
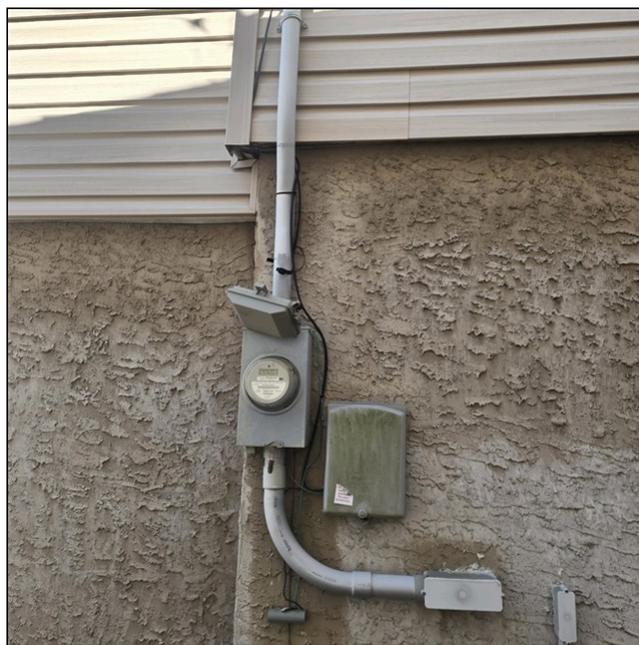
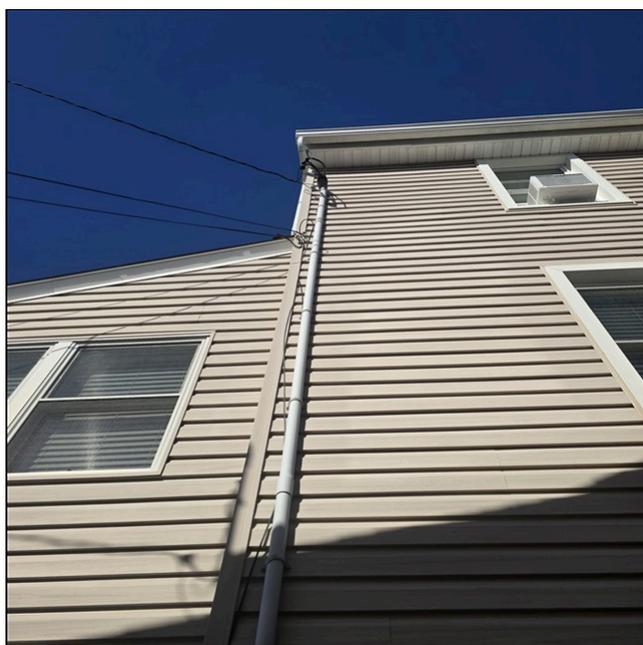
Home's electrical is fed from an overhead service. This is for your information.

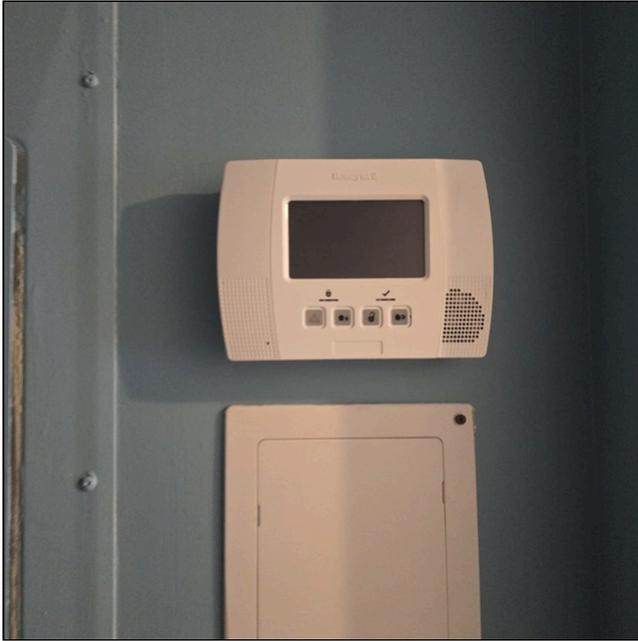
8.6 Item 1 (Picture)

The security system is outside the scope of the home inspection. I suggest contacting the seller or having the system fully evaluated by a home security specialist.

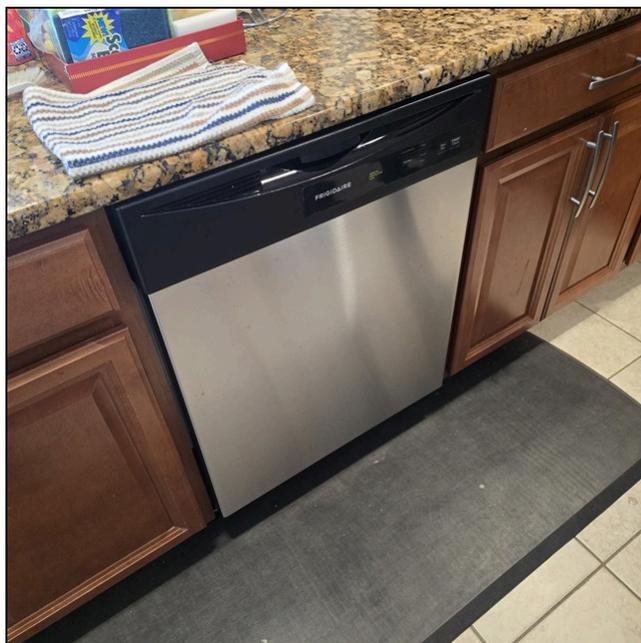
9.0 Item 1 (Picture)

The dishwasher was tested and operational during the time of inspection.

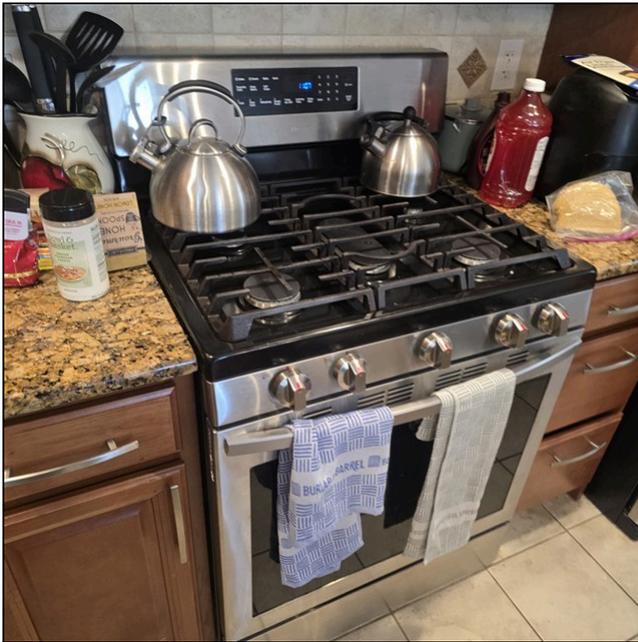
9.1 Item 1 (Picture)

The stove was operational. Anti tip bracket was present.

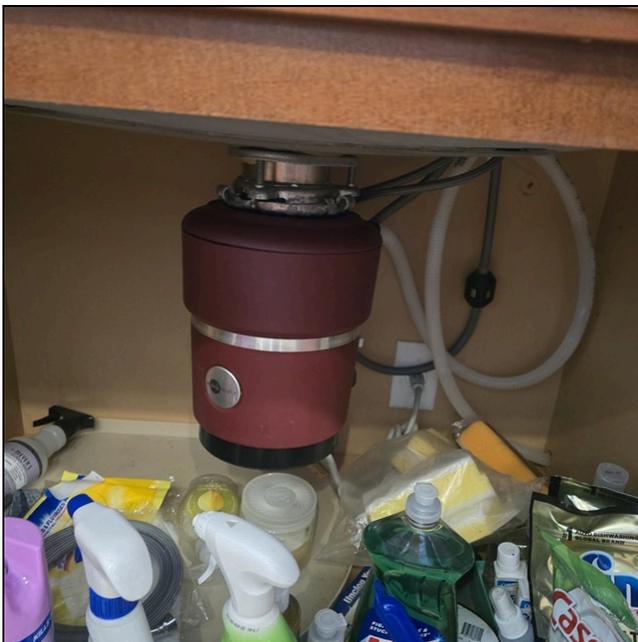
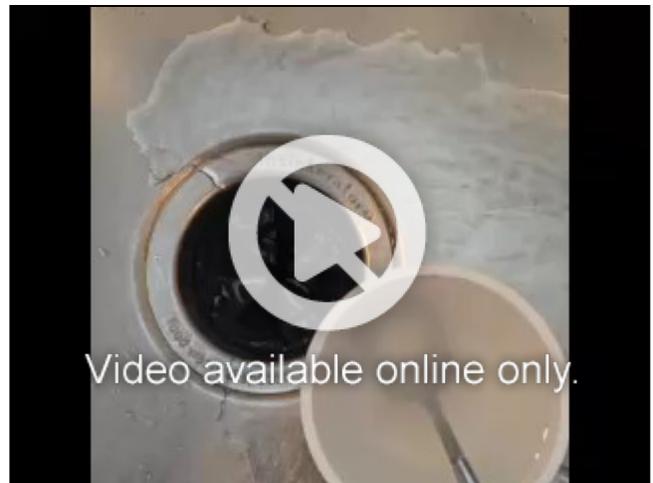
The food waste disposer was operational during the time of inspection.

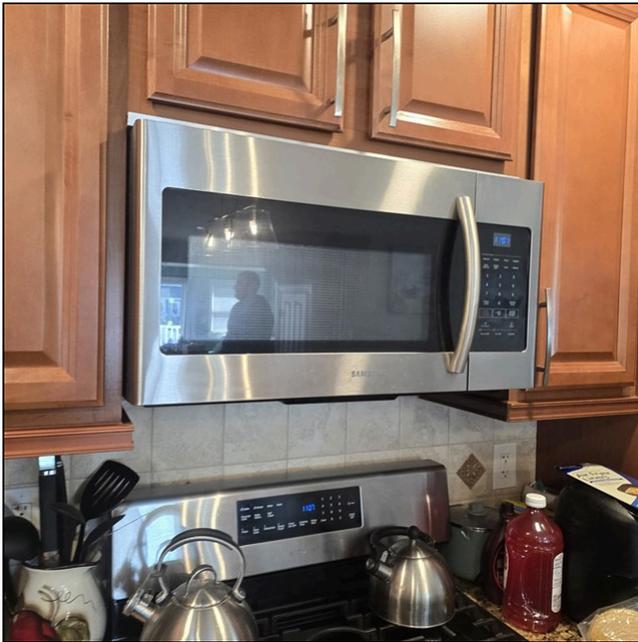
9.4 Item 1 (Picture)

The microwave was operational.

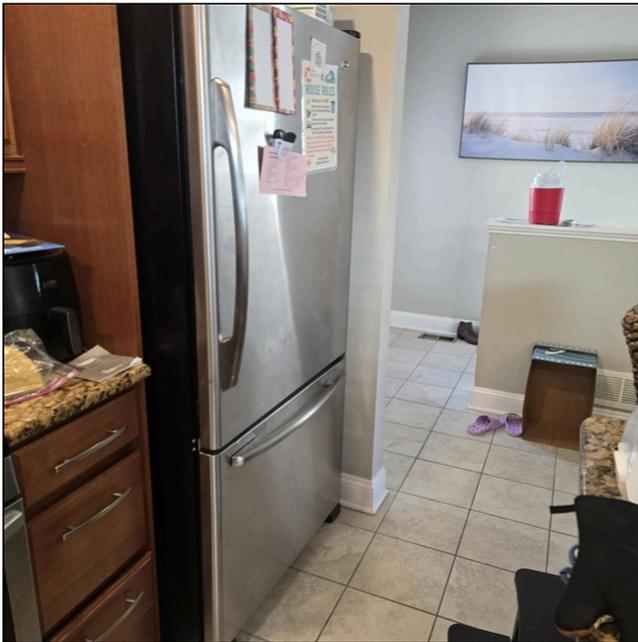
9.5 Item 1 (Picture)

The refrigerator was operational during the time of inspections.

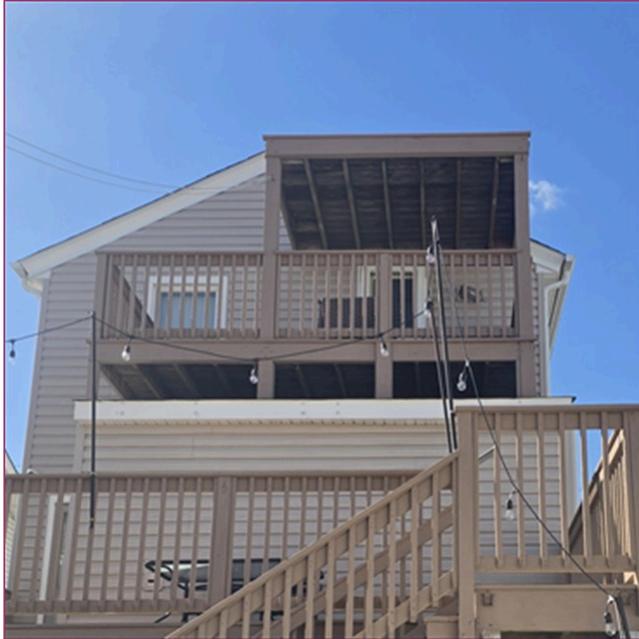
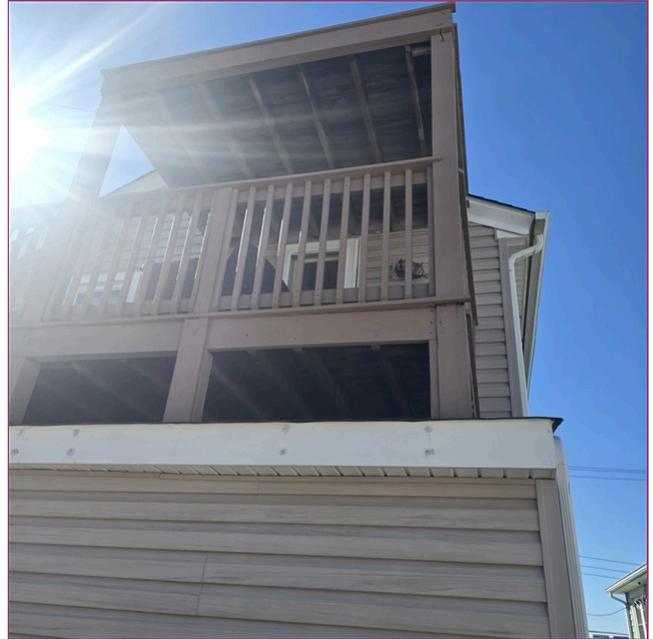
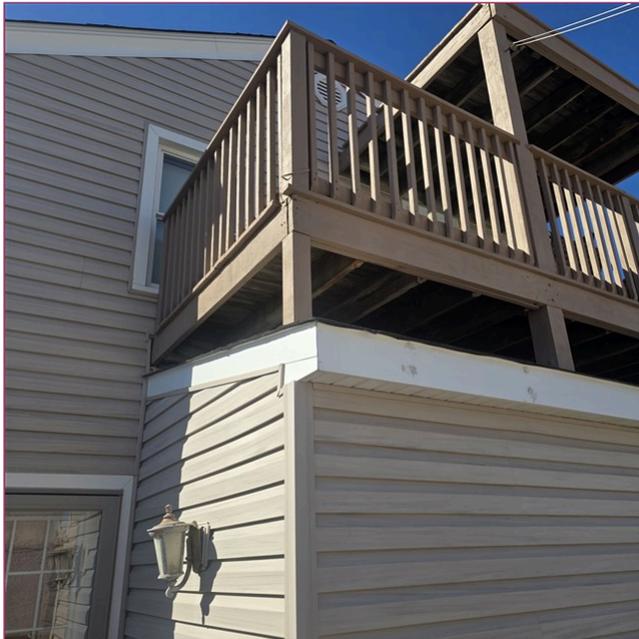
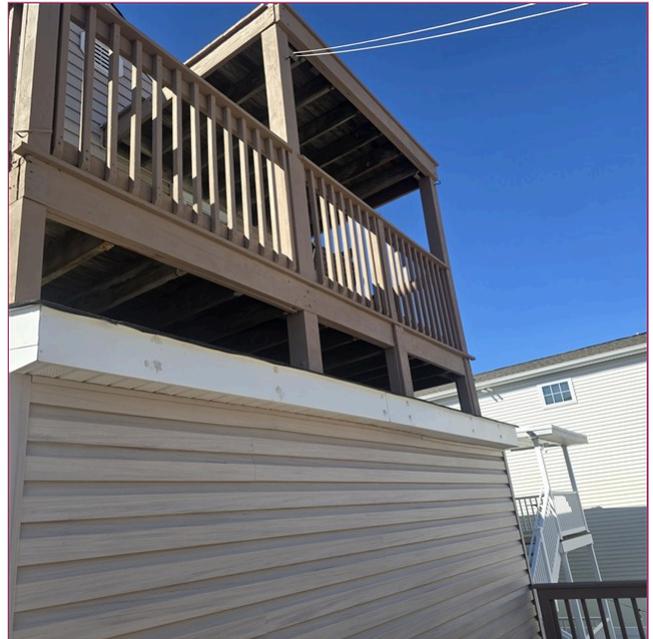
The client provided an aerial image of the home showing that the structure previously consisted of a deck over a roof surface with an additional higher deck above it. The highest section has since been removed; however, portions remain, including deck boards that are now acting as a roof surface to some degree. This configuration is improper and increases the risk of water intrusion and structural concerns.

This condition is unsafe. Recommend removal or full replacement of this deck.

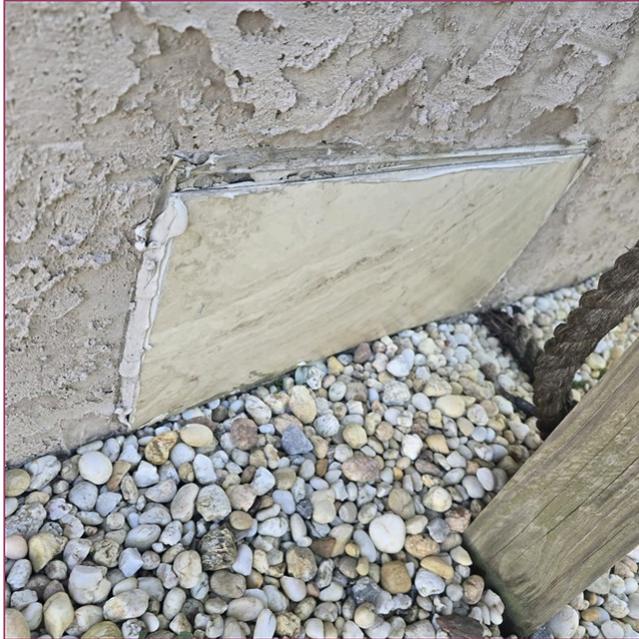
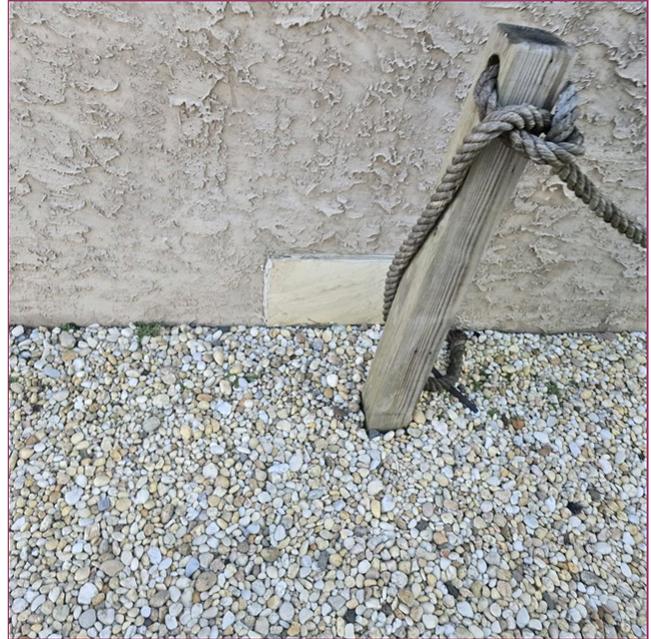
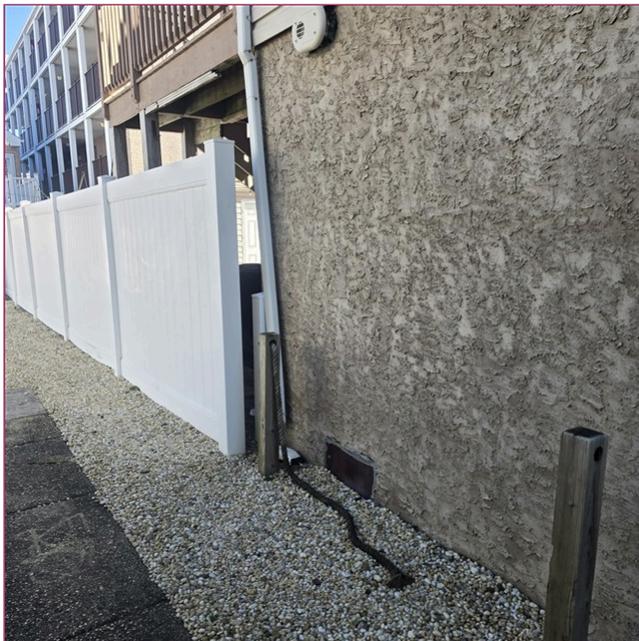
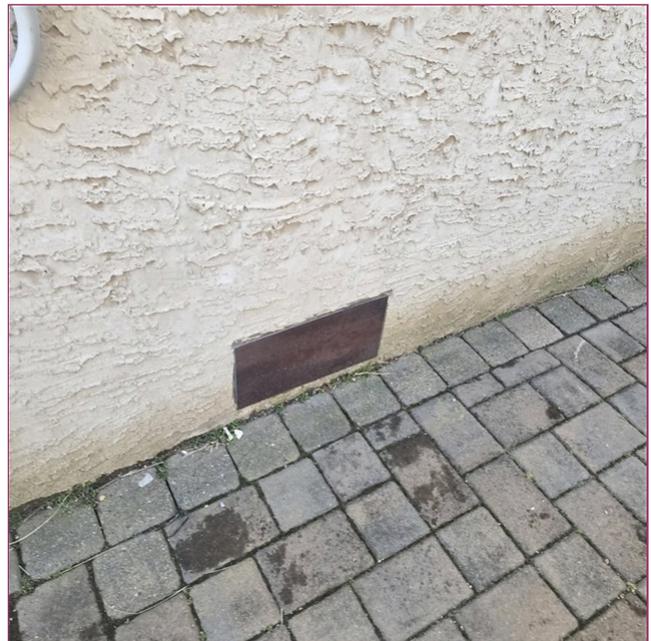
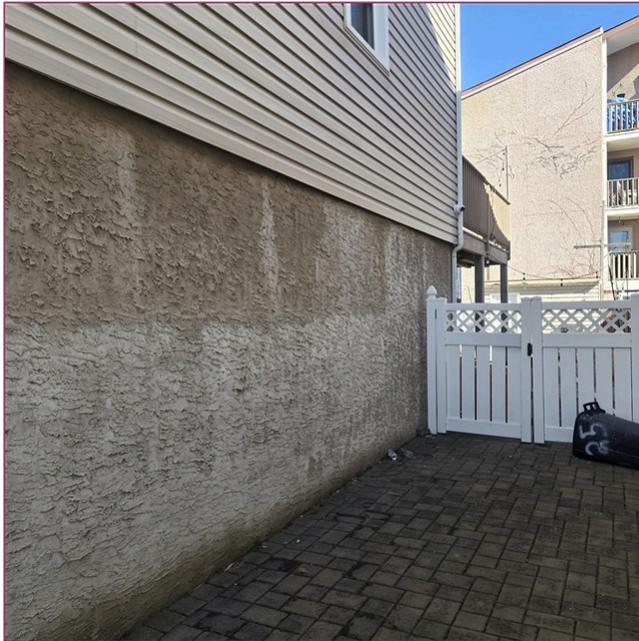
(3) Openings consistent with vents or drains were observed at the base of the foundation. The home appears to have been elevated at some point to raise the living space above the flood line. These openings are typically intended to allow for water movement and pressure equalization in flood conditions.

At the time of inspection, several of these vents were obstructed by foam insulation boards and covers, and no metal grates were observed. Obstruction of these openings may limit proper function during flood events. The neighboring property was observed to have more frequent vent openings.

1.4 Item 6 (Picture) may need additional vents.

These openings are often subject to FEMA flood vent requirements. The inspector is not familiar with specific FEMA compliance requirements. Recommend further evaluation and confirmation that the installation meets applicable FEMA requirements, and optimize the number, placement, and condition of these vents/drains as needed.

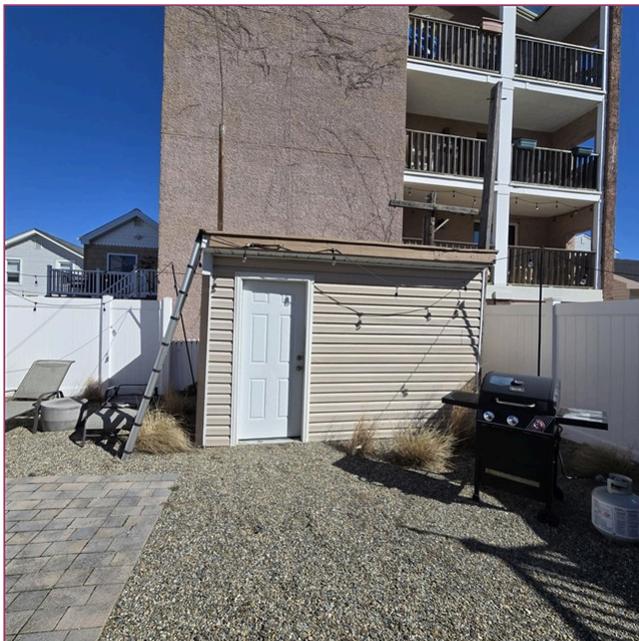
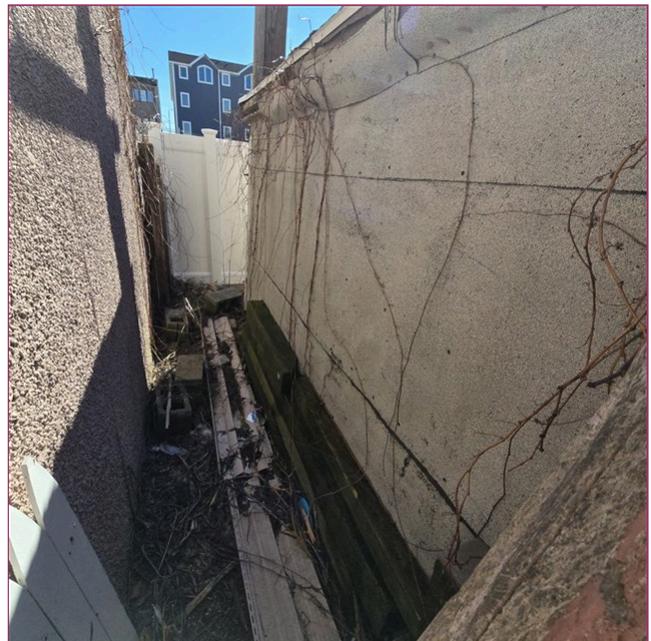
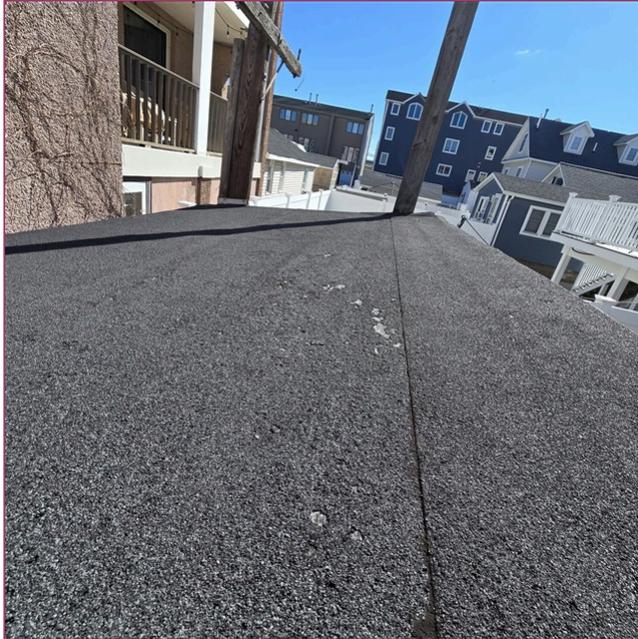
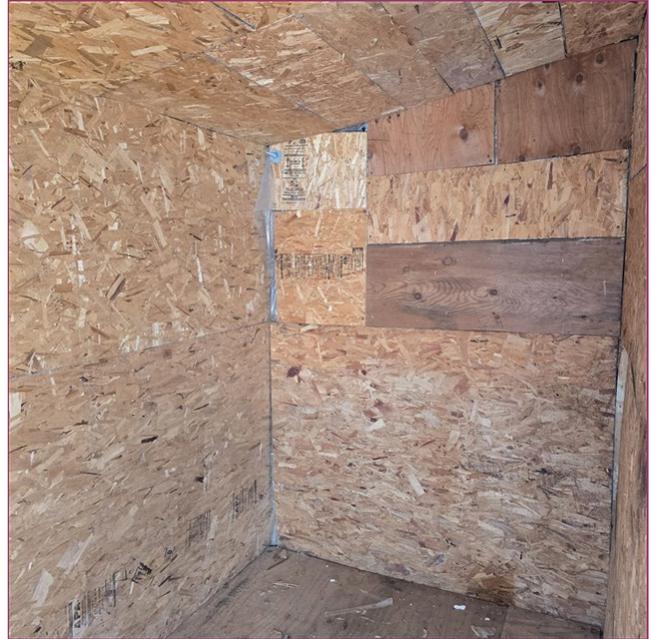
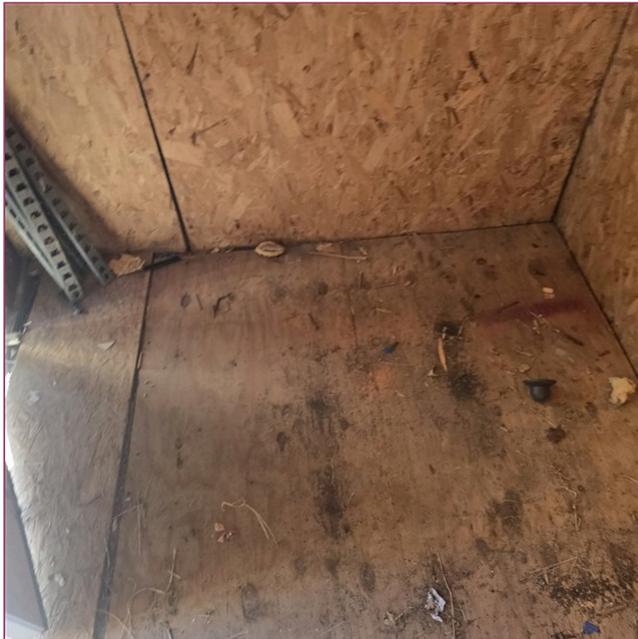
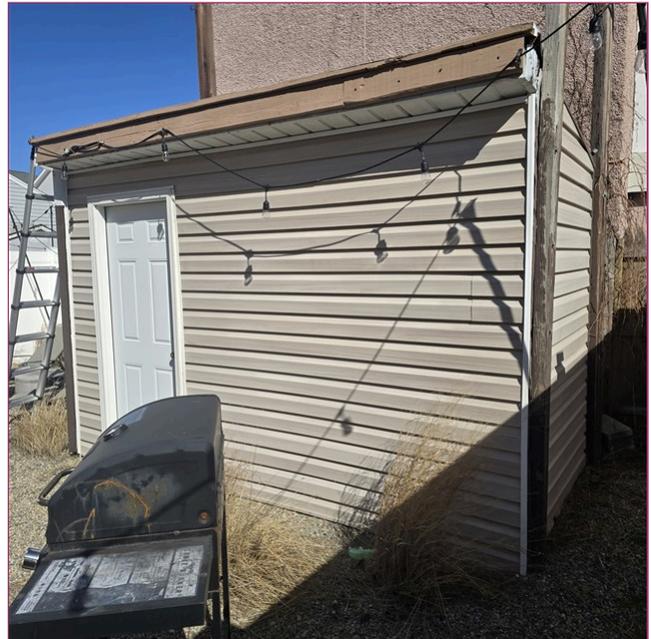
The shed was observed to be in poor condition. The rolled roofing material was worn, and the exterior cladding showed deterioration. The interior framing was obstructed by installed OSB panels, limiting inspection. The shed appears to be built directly on grade. Recommend repairs or replacement as needed.
