Inspection Report

Property Address:
75 West Amazing Life Steet
Near the Beach NJ 08540

Master Building Inspections

Property Address 75 West Amazing Life Steet Near the Beach NJ 08540	Date of Inspection 3/17/2026	Report ID 202603283341-1930-2300
Customer(s) Susan Green	Time of Inspection 10:30 AM	Real Estate Agent

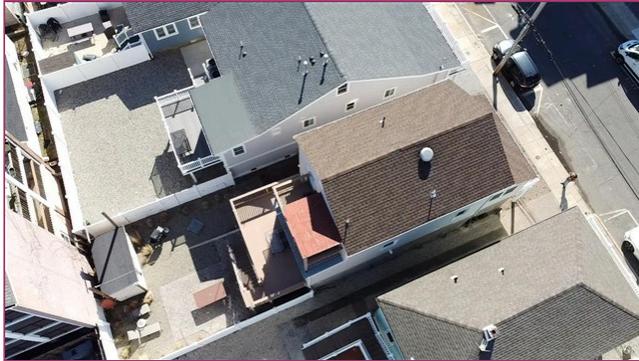
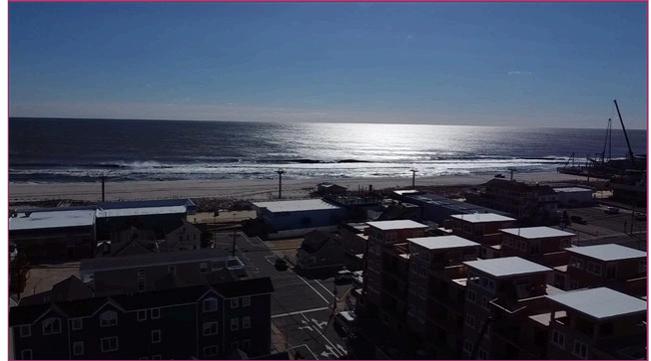
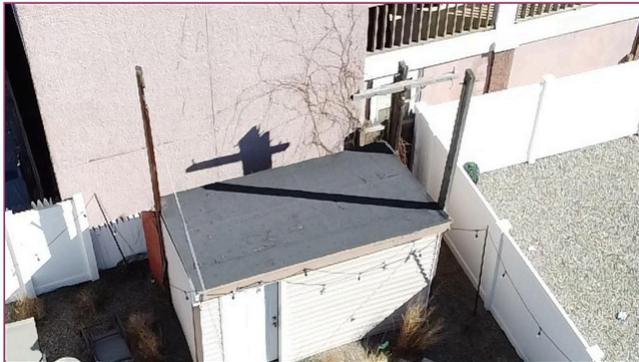
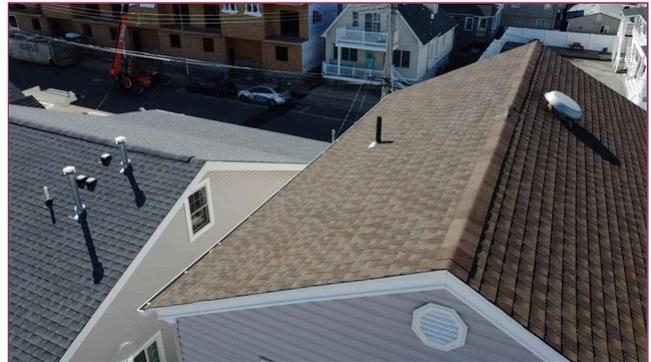
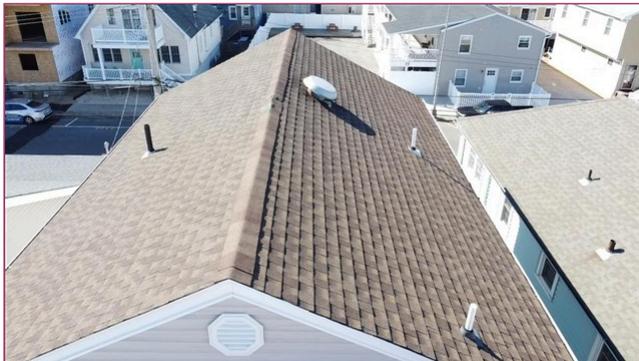
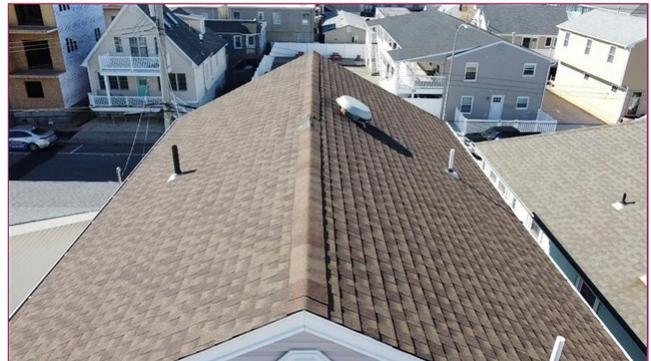
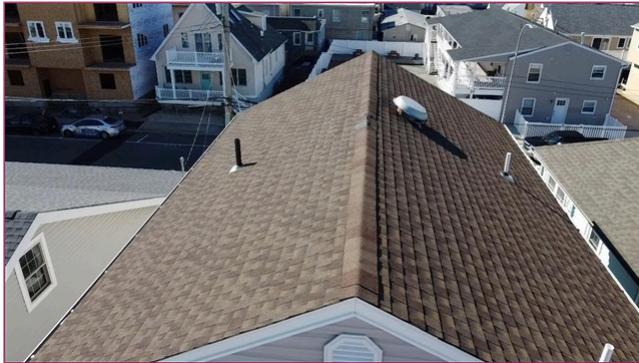
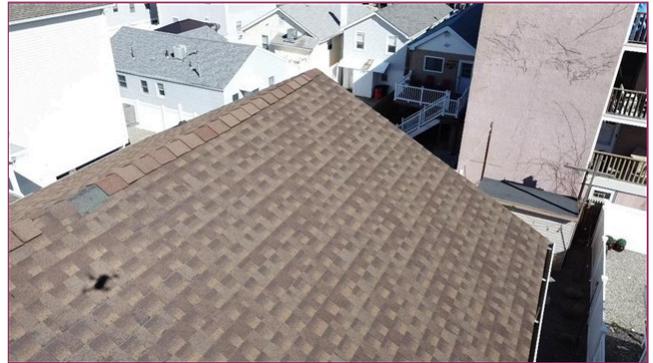
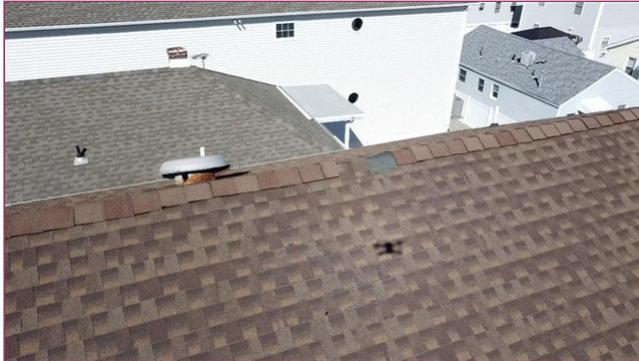
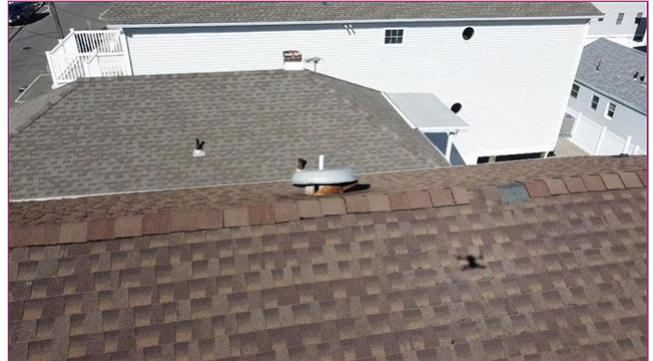
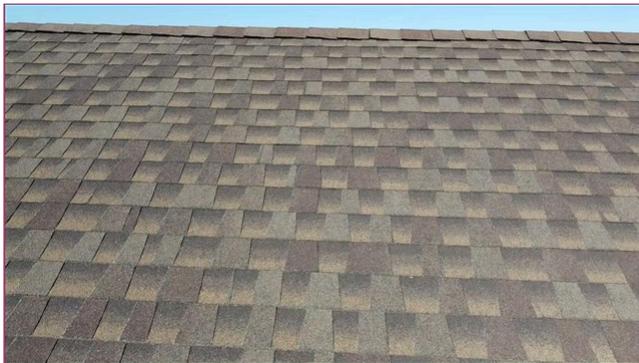
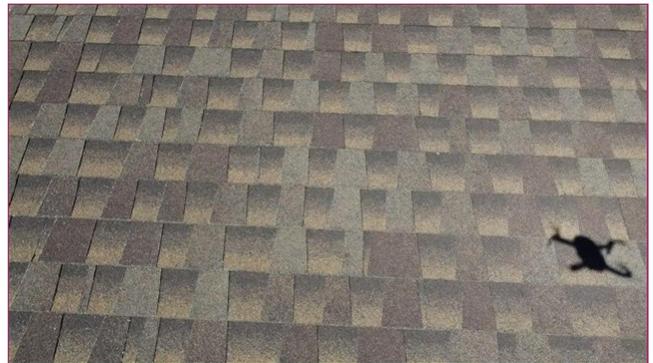
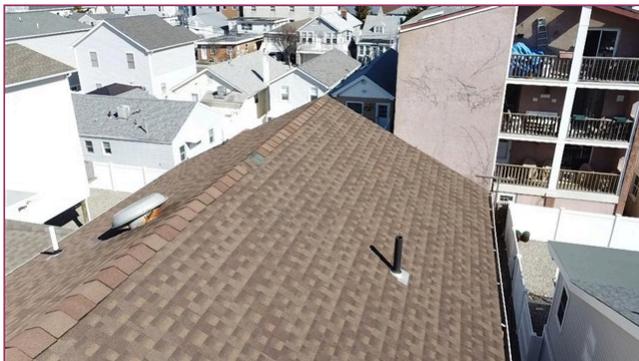
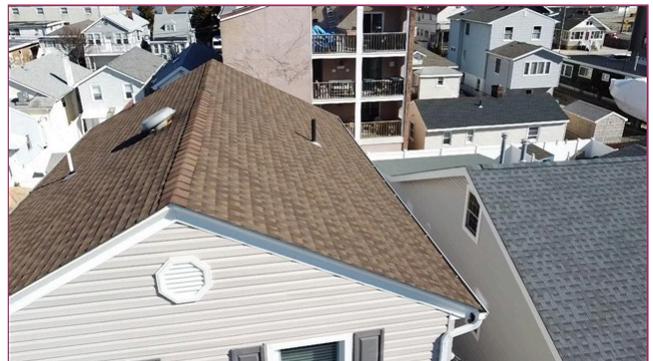
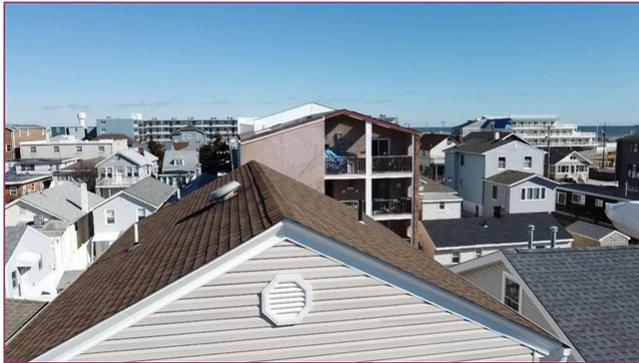
The main asphalt shingle roof was observed to be in fair to good condition. The ridge vent cap was damaged and should be repaired to help prevent moisture intrusion.

The roofing surface over the upper deck consisted of wood deck planks. These were observed to be worn and may require maintenance or replacement.

The shed roof was observed to be in poor condition, with exposed fiberglass present. Replacement is recommended.

The roofing surfaces over the front balcony and beneath the upper rear deck were observed to be older, with evidence of damage, exposed fiberglass, and active leaking in one or more locations. Recommend replacement of these smaller roofing sections. The rear deck will need to be removed to properly address the roofing beneath.

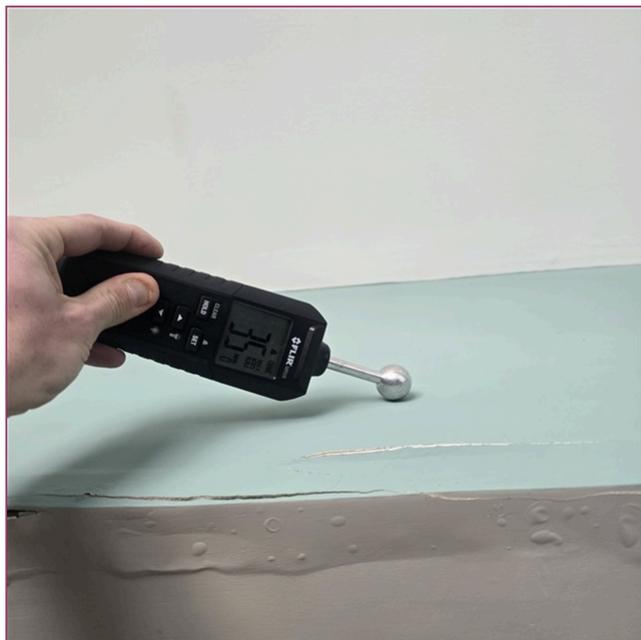
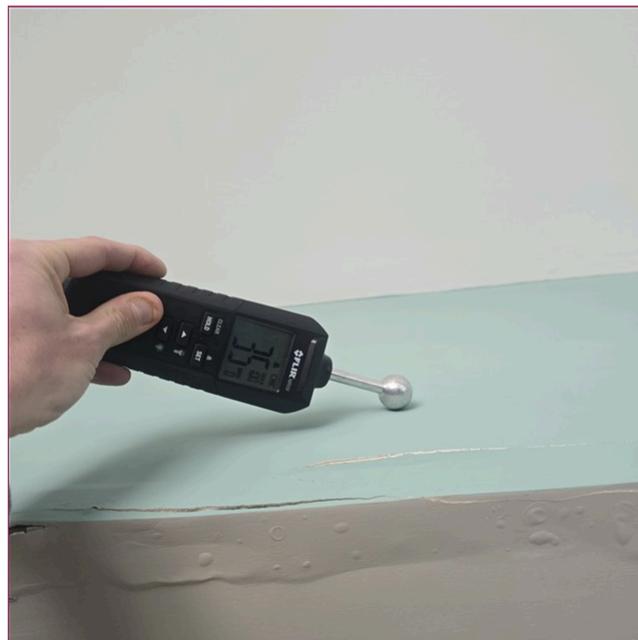
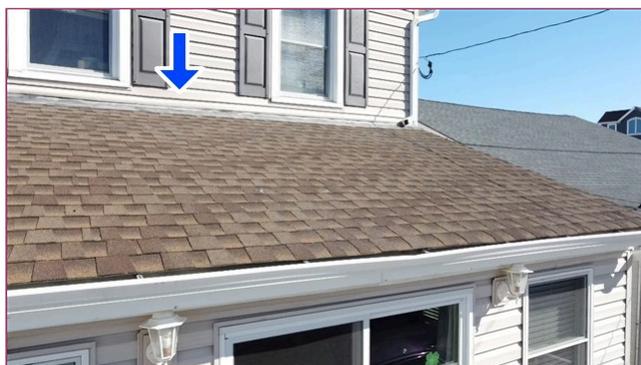
An active leak was observed at the second-floor front section of the home. The headwall flashing appears to be failing, and the roof is older. Moisture testing with a non-destructive meter indicated elevated readings consistent with saturation. Concealed damage should be expected. Recommend further evaluation and repair as needed.

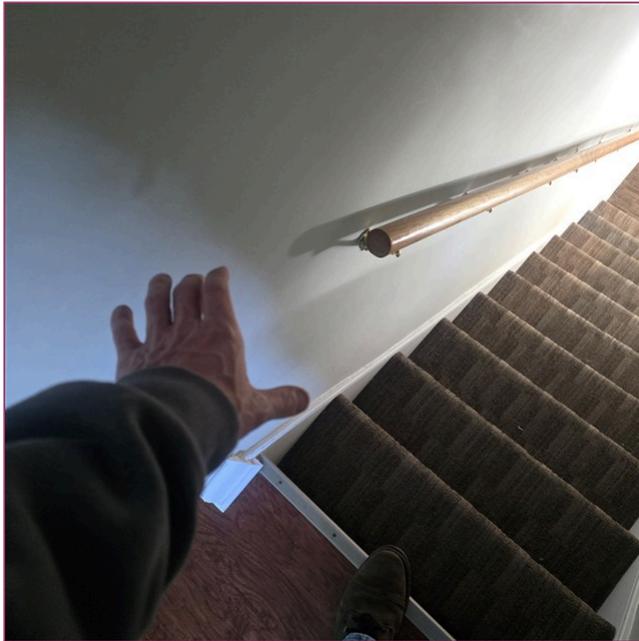
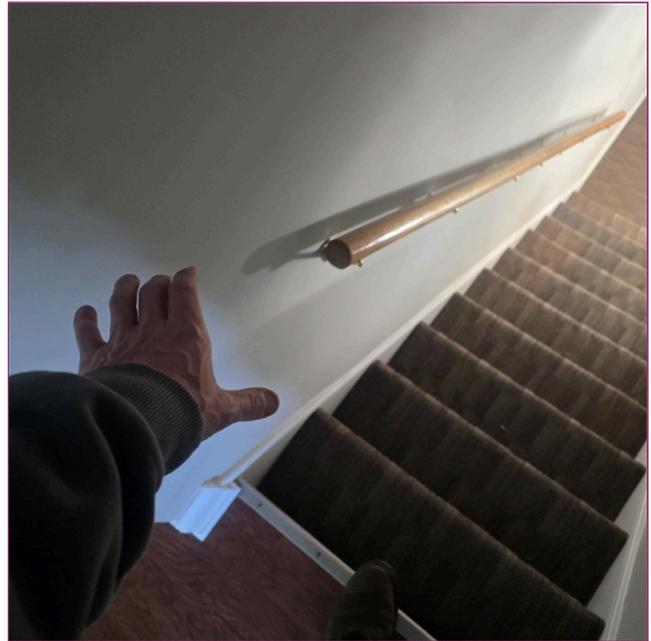
(2) The handrail does not fully extend to the top floor, creating a safety hazard. Extend or modify the handrail to provide continuous support.

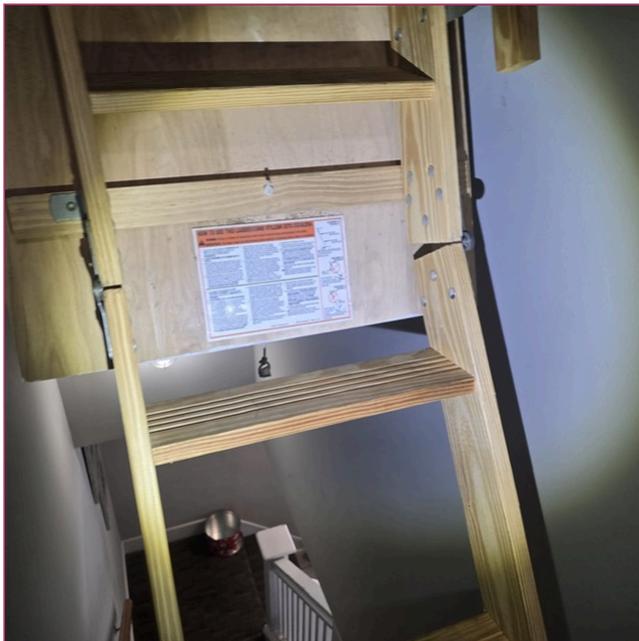
5.4 Item 1 (Picture)

(1) The pull-down attic stairs were overextended, creating a potentially unsafe condition. Repair or adjustment is recommended to ensure proper operation and safe use.

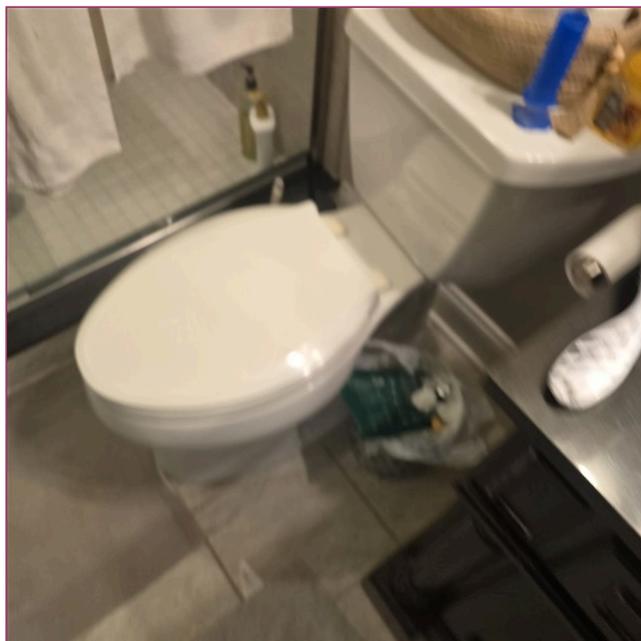
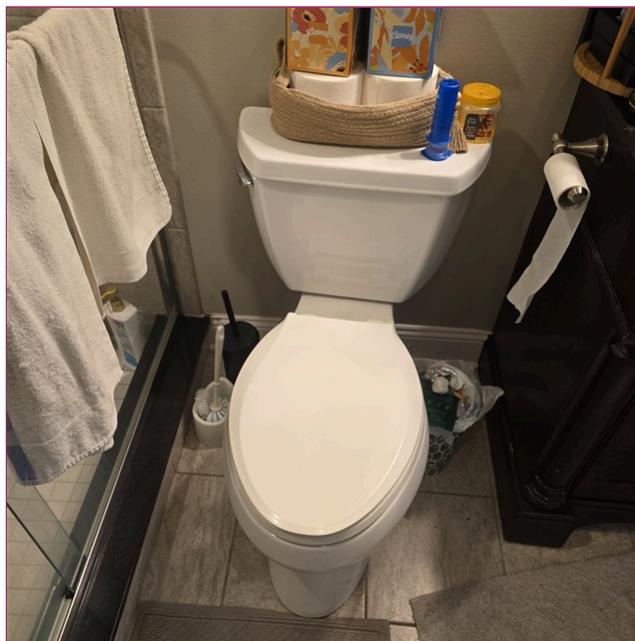
(2) The toilet base is loose in the room(s) in the photographs below. A loose toilet can have several implications, including: Water leaks: If the toilet is not securely anchored to the floor, it can cause water to leak around the base of the toilet. This can cause damage to the surrounding flooring and even lead to mold growth. Unpleasant odors: If the toilet is not tightly sealed to the drainpipe, sewer gases can escape and cause unpleasant odors in the bathroom. Structural damage: A loose toilet can eventually cause damage to the surrounding flooring and subflooring. If left unrepaired, this can lead to costly repairs. Safety hazards: A wobbly toilet can be a safety hazard, especially for children or the elderly, who may be at risk of falling or slipping. Inefficient flushing: A loose toilet can result in inefficient flushing, which can lead to clogs and require more frequent cleaning. It is important to address a loose toilet promptly to prevent these potential problems and ensure the safety and functionality of your bathroom.

I recommend further evaluation to ensure no concealed damage is present. I recommend repairs as needed by a licensed professional.

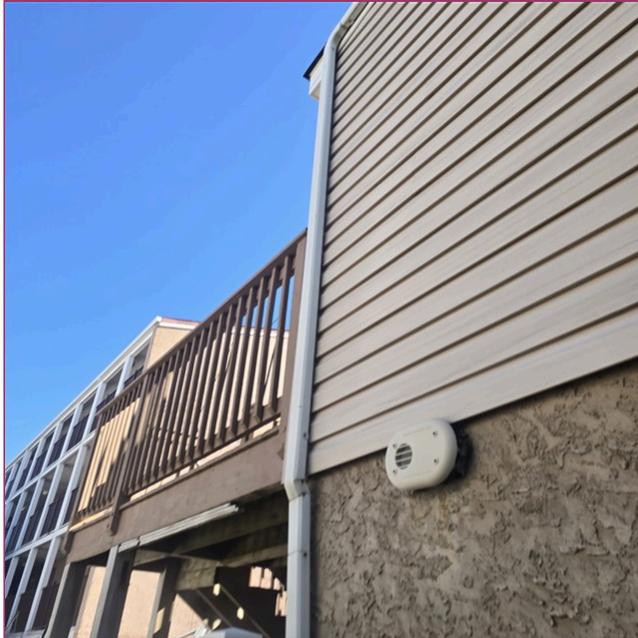
6.2 Item 1 (Picture)

(3) The water heater was not accessible at the time of inspection, as two closets in the garage were locked. As a result, the age, condition, and overall installation of the unit could not be determined.

A high-efficiency sidewall vent was observed terminating at the rear of the home near the deck. While this vent is consistent with typical exhaust for a high-efficiency appliance such as a water heater or furnace, its exact source could not be confirmed. This type of vent discharges exhaust gases and moisture; use caution in this area.

Recommend having the water heater made accessible and fully evaluated prior to purchase to determine its age, condition, and any defects. Failure to do so may result in unexpected repair or

replacement costs.

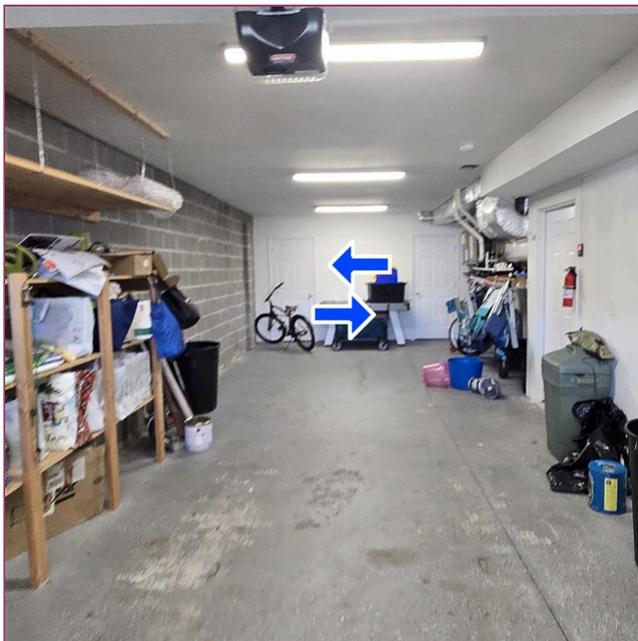
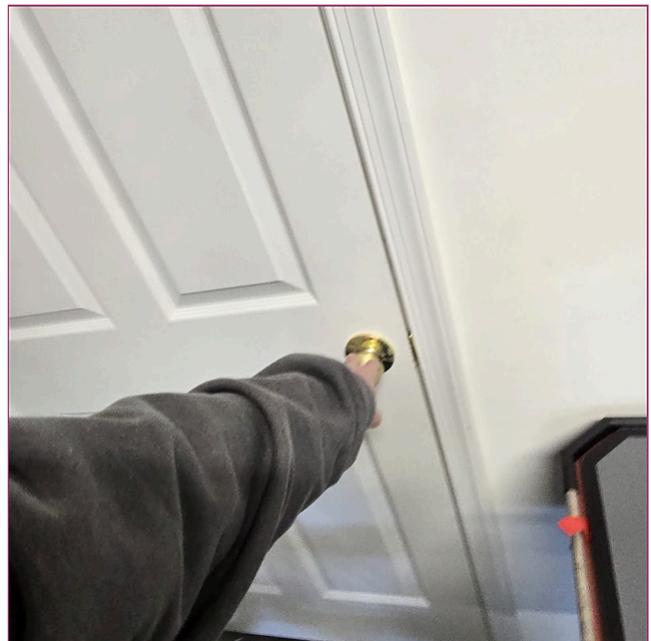
Plumbing components, including the waste piping, main water shut-off, and water heater, were not observed as the utility closets in the garage were locked. Failure to have these areas inspected prior to purchase may result in significant unexpected expenses. Recommend gaining access and having these areas fully inspected prior to purchase.

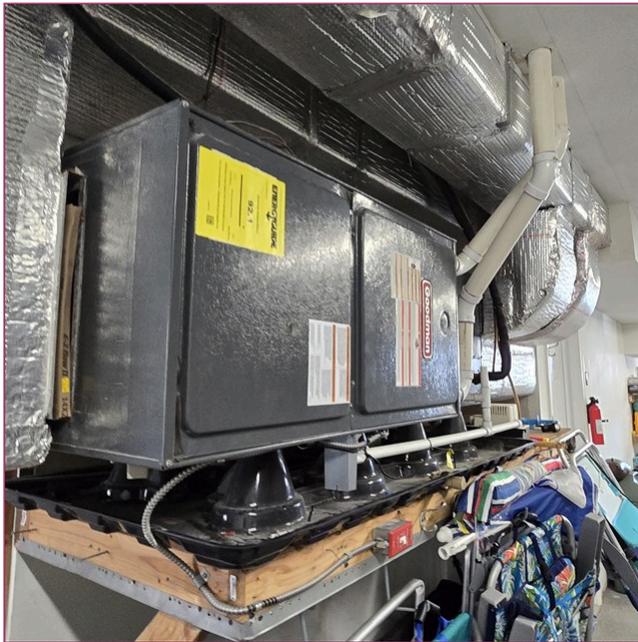
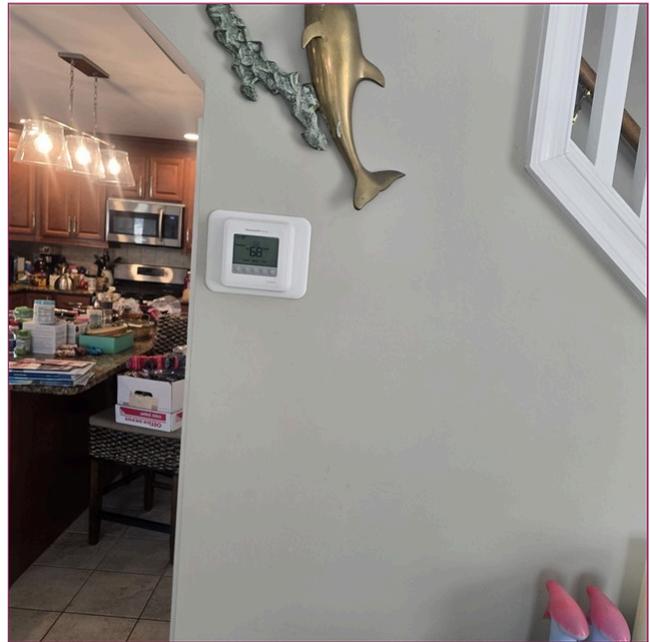
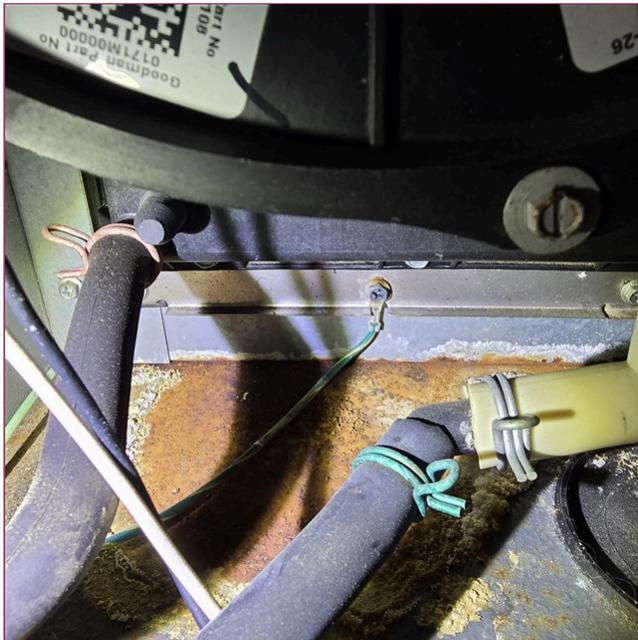
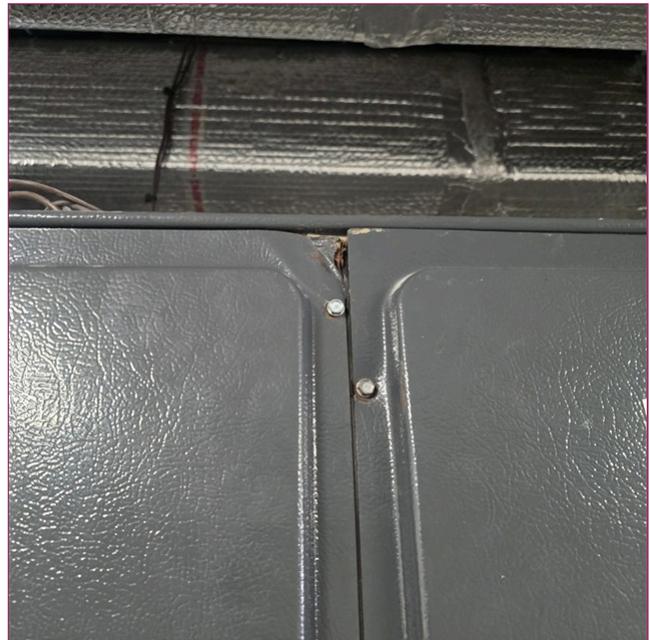
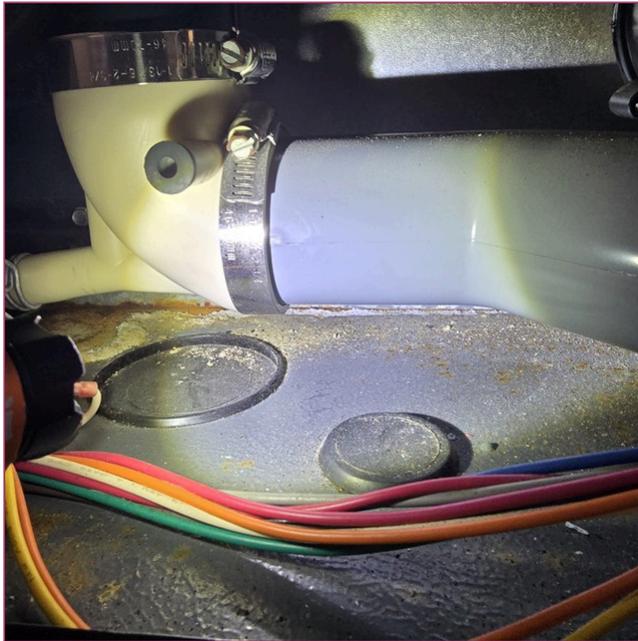
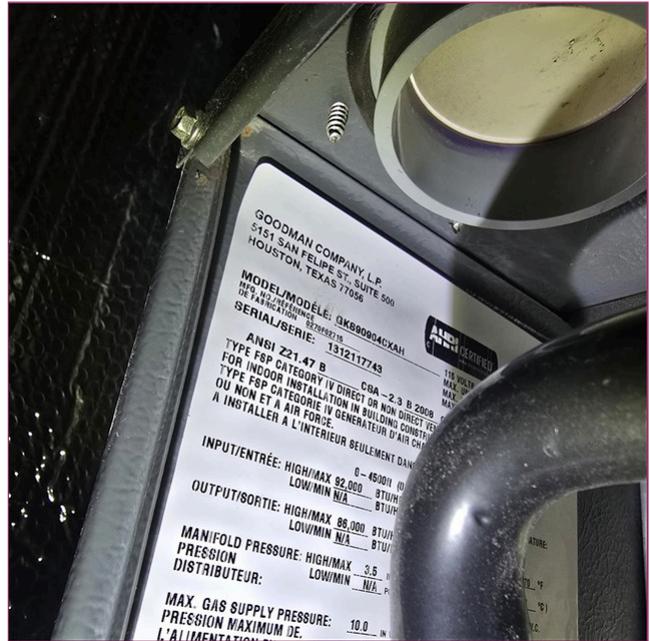
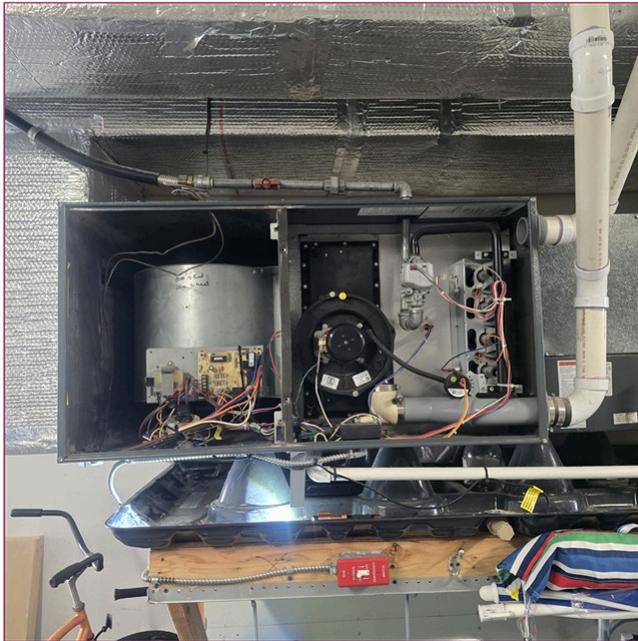
The furnace was manufactured in 2013 and is located in the garage in an elevated position. Evidence of rust and corrosion was observed. Corrosion was noted beneath the vent connection, indicating a need for service.

The system is in need of servicing. As a precaution, the heat exchanger should be evaluated. Similar furnaces typically have an estimated serviceable life of approximately 15 to 20 years under normal conditions. In coastal environments, the serviceable life is often reduced due to exposure to moisture and salt air. Based on the observed condition and age, budget for replacement.

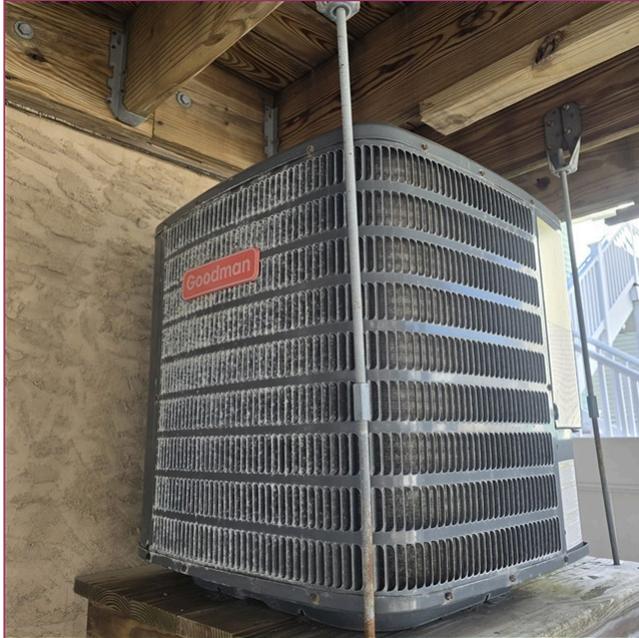
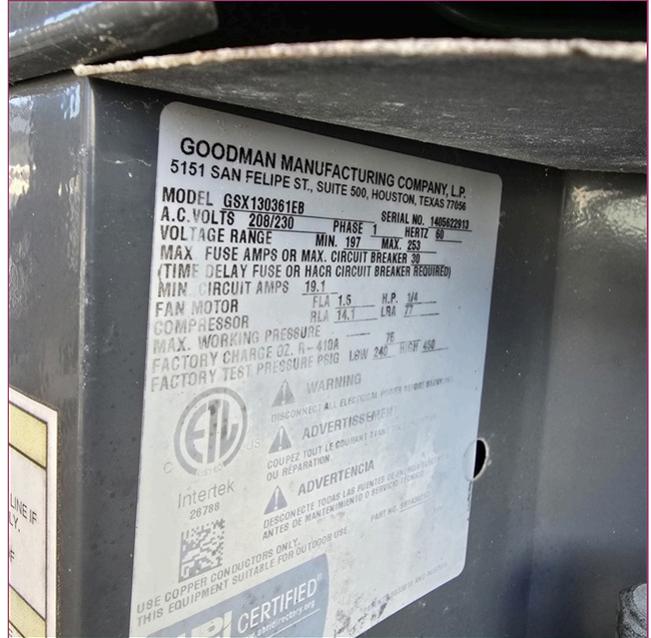
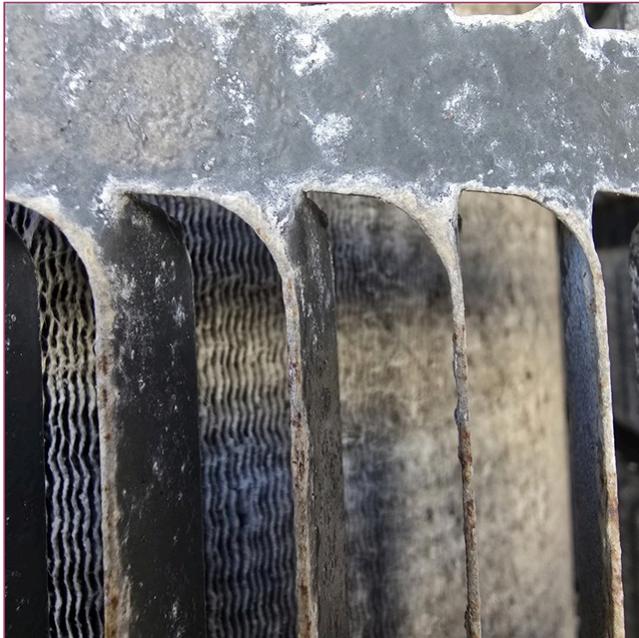
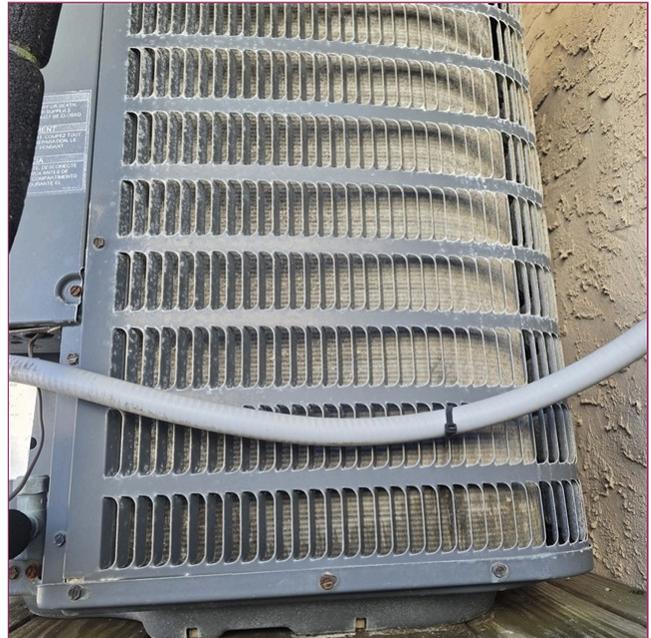
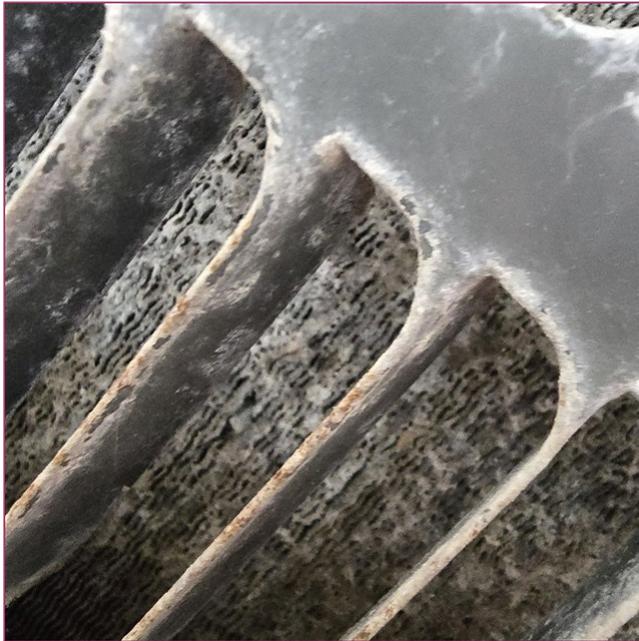
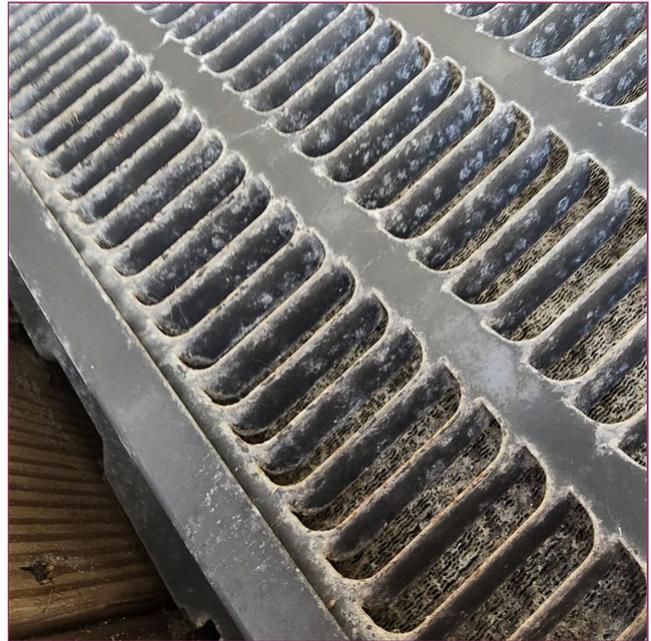
The air conditioning condenser was manufactured in 2014 and was observed to be in poor condition. Significant corrosion was present, consistent with prolonged exposure to a coastal environment. The system was not tested due to outdoor temperatures being below 65 degrees at the time of inspection. Window air conditioning units were observed serving the upstairs bedrooms.

In coastal environments, air conditioning equipment is subject to accelerated deterioration due to salt air and moisture. Similar systems in these conditions typically have a reduced serviceable life compared to inland units. Routine maintenance, including regular cleaning, coil rinsing, and protective coatings, can help prolong equipment life. Equipment specifically designed for coastal or high-corrosion environments may also be considered for improved durability.

Based on the observed condition, the main system may require immediate replacement. Budget for replacement is recommended.

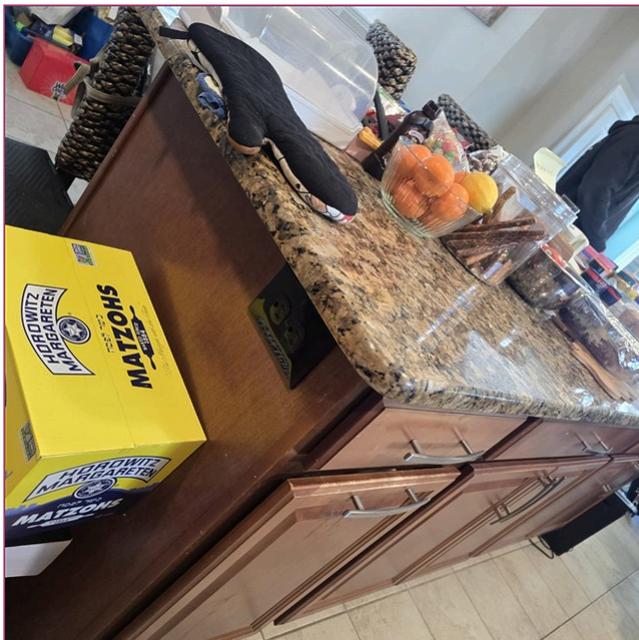
8.3 Item 3 (Picture)

(2) There is an outlet on the side of the kitchen island. A child can pull a wire plugged into this location and be injured. I recommend not using this plug and or removal of the plug.

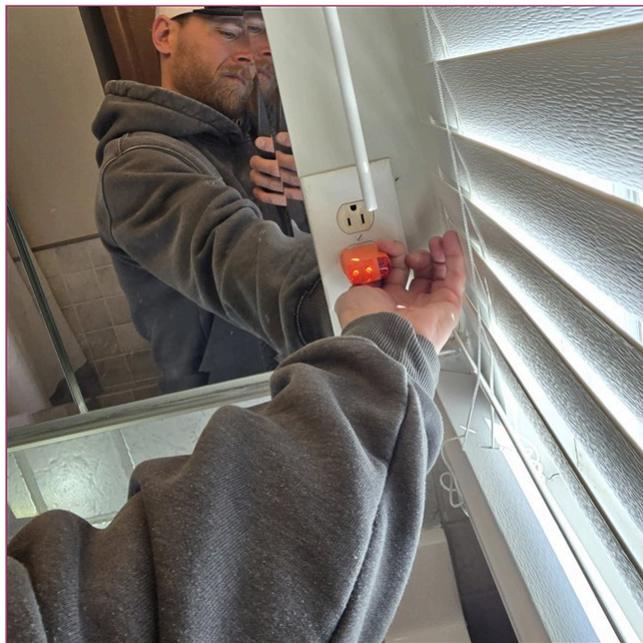
No Ground Fault Circuit Interrupter (GFCI) protection of the home's (see photograph(s) below for locations) electrical outlets was provided in the home at the time of inspection. I suggest having a licensed contractor installed GFCI protected outlets in this/these area(s) for safety.

8.4 Item 1 (Picture) upstairs bathroom.

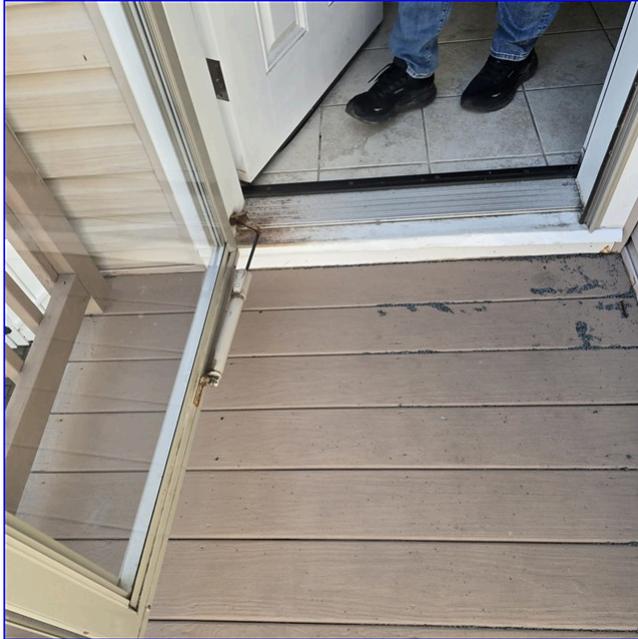
1.1 Item 2 (Picture)

(2) Exterior back door was built at the same level as back deck/patio/porch. This can allow rain or overflow from gutters to penetrate door jam area causing damage to framing below. It is recommended to have a 4 inch step up from exterior doors to prevent this issue. This is not possible with out rebuilding the deck/patio/porch. I recommend further evaluation to determine if the flashing is present. If no flashing is present, have the contactor install a proper flashing or water sealant under at bottom door jam/transition can be sufficient.

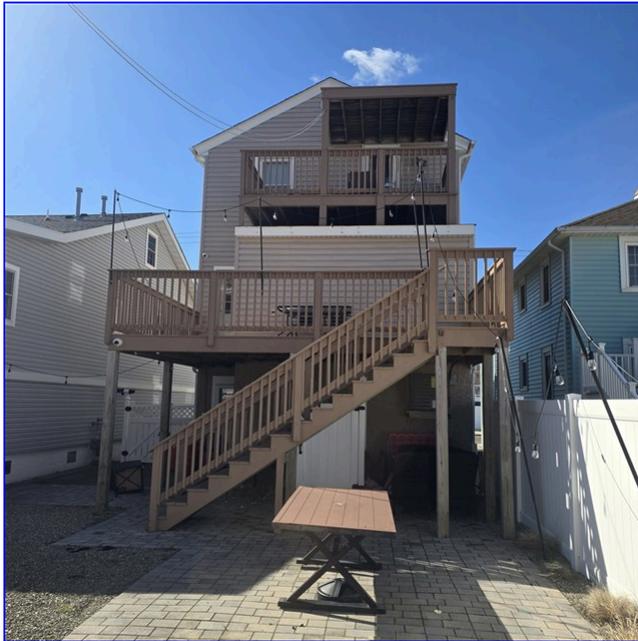
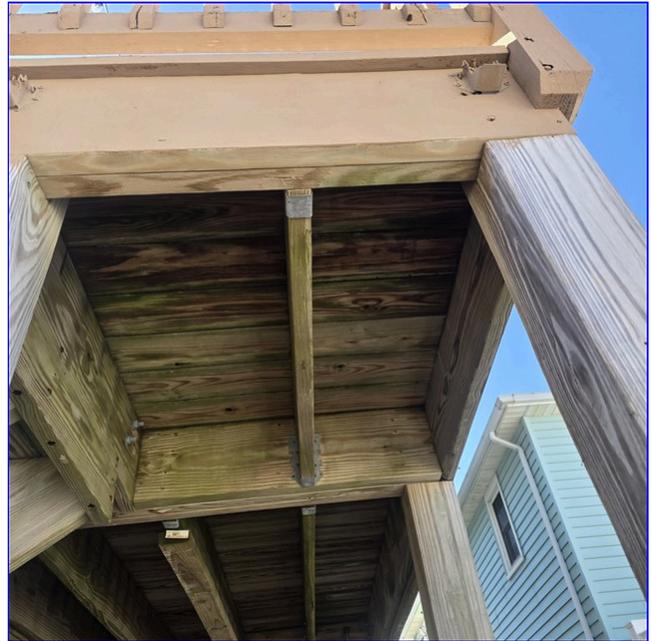
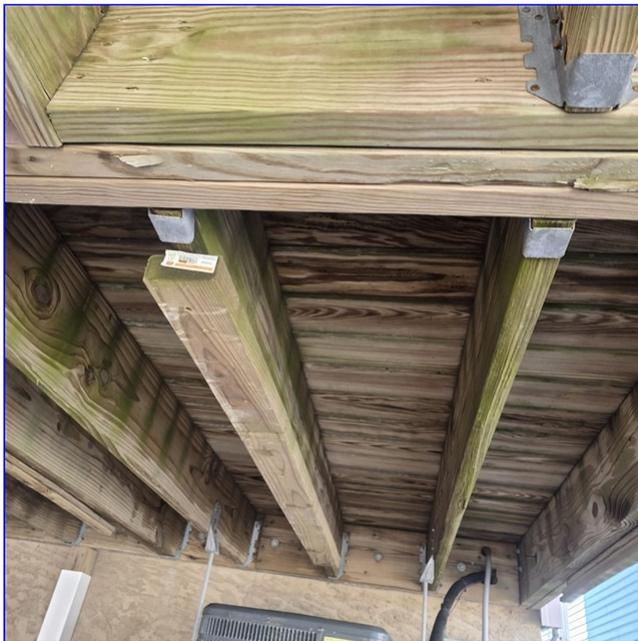
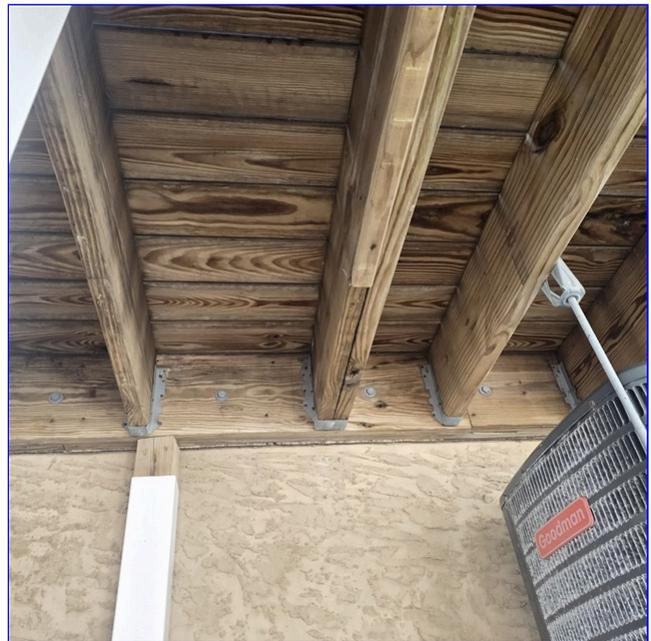
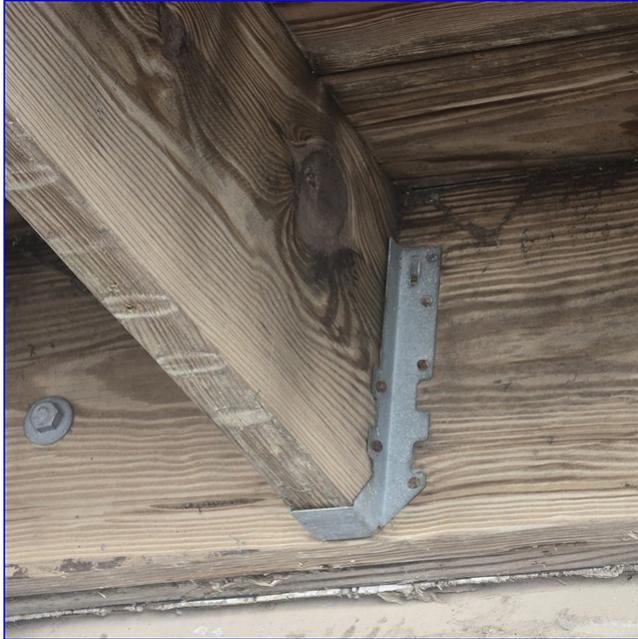
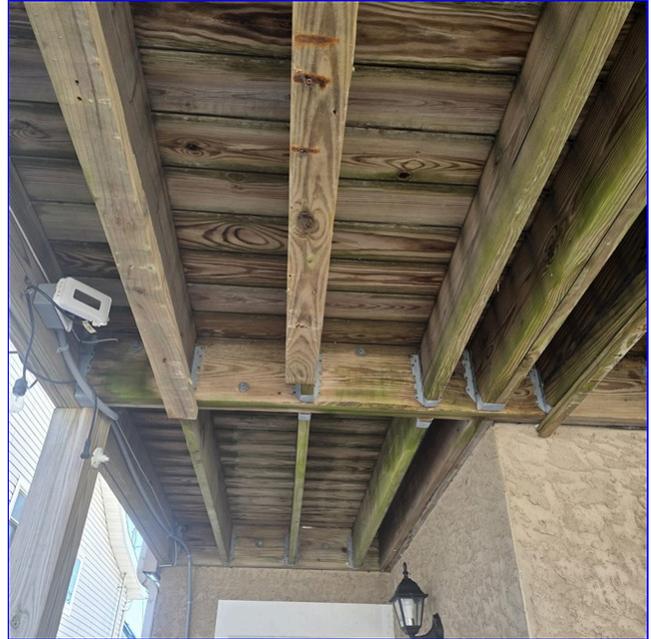
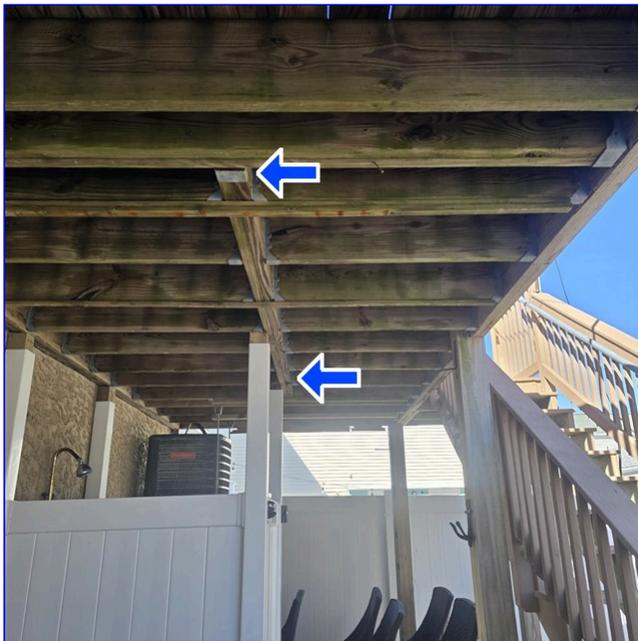
One concern was noted with the deck framing. The floor boards are secured at the center of the deck to doubled floor joists, with a connection occurring between the ledger board and rim board within the deck plane. This configuration suggests that a portion of the deck load may be transferred through interior framing members rather than being fully supported at the ledger and outer beam as typically expected. This is an unconventional load path.

Recommend checking for permits and having the deck framing further evaluated to confirm proper structural design and support.

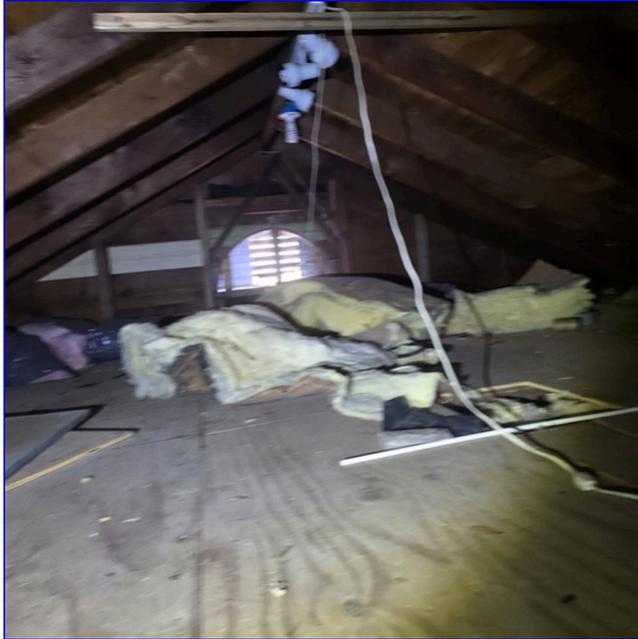
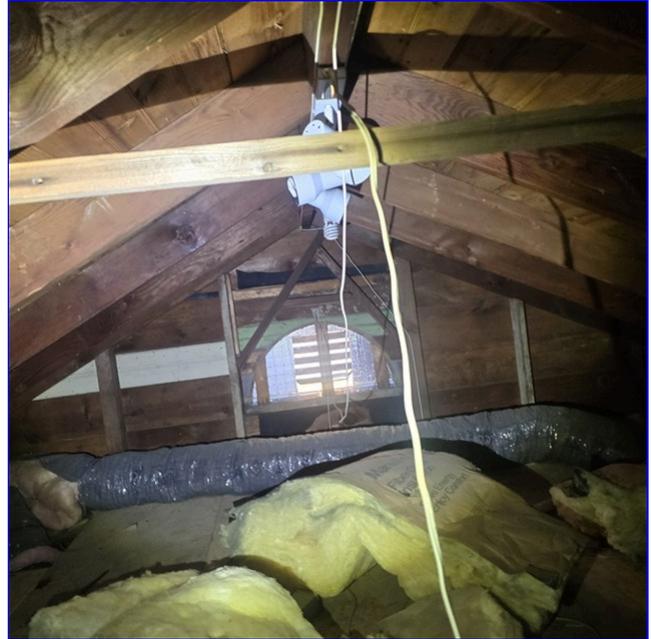
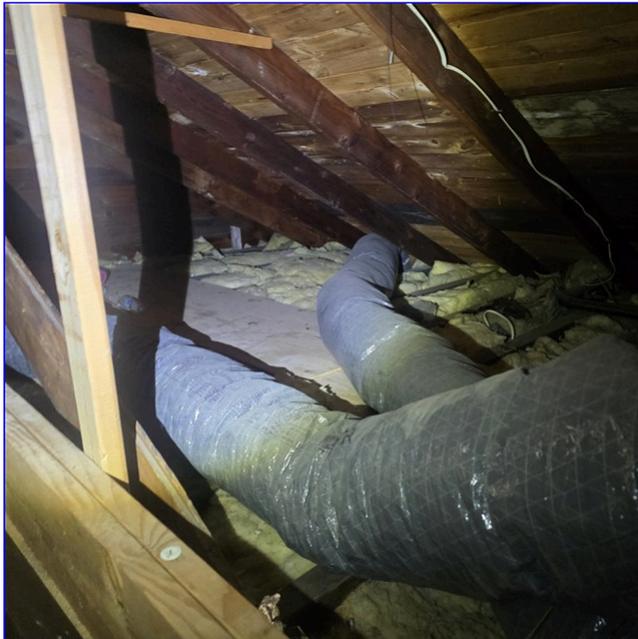
The attic was floored over, which obstructed the view of most to all insulation. This limited evaluation of insulation levels and condition. Further evaluation is recommended as a precaution. Inadequate or unknown insulation may contribute to increased energy costs.

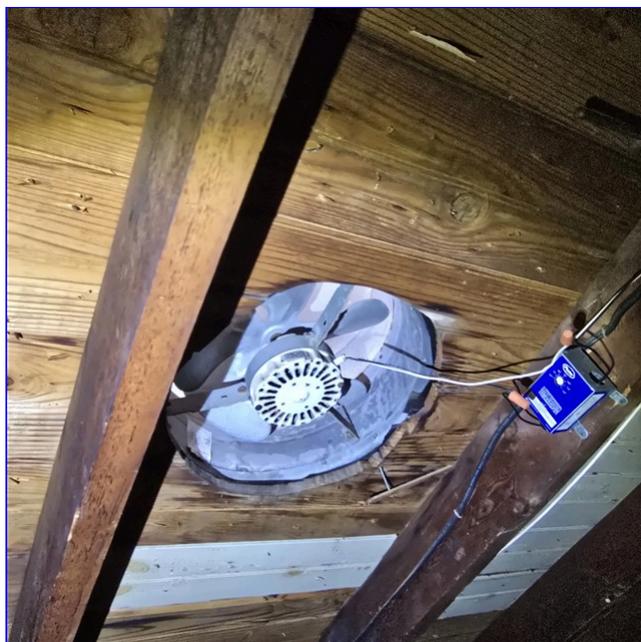
3.3 Item 1 (Picture)

The attic fan was not tested as the temperature was too cool to initiate the fan. I suggest making the sure the fan is operational and safe when the exterior temperature is much warmer. The fans purpose is to aid in venting the hot attic air during warmer months. This helps the roof surface cooler which prolongs the life of the roof.

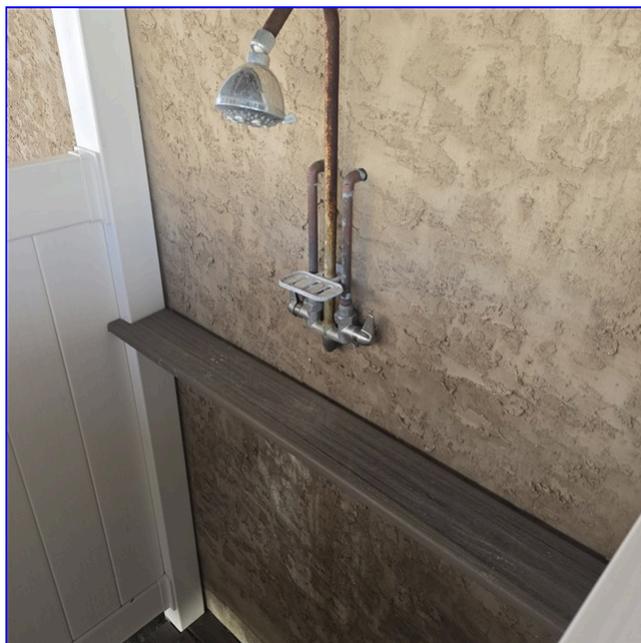
6.0 Item 1 (Picture)

(1) An exterior shower was present and appeared to be winterized at the time of inspection. The utility room in the basement was locked, and the internal plumbing components associated with this system were not inspected. Recommend further evaluation prior to purchase to confirm proper condition and to ensure no defects are present.

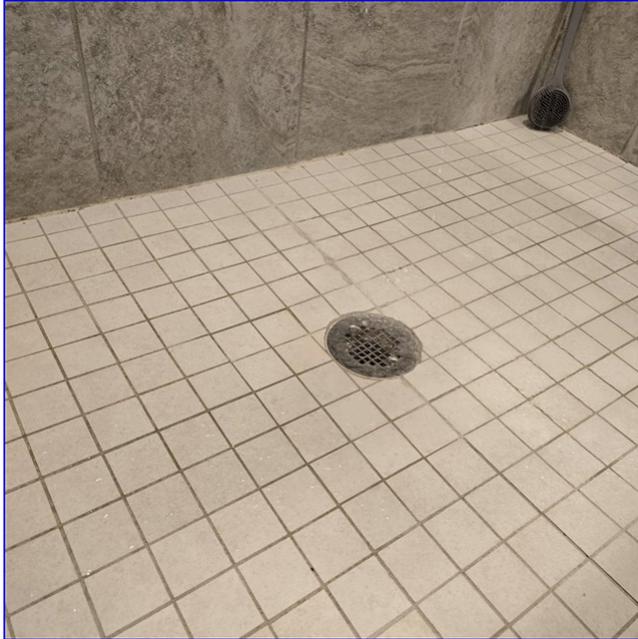
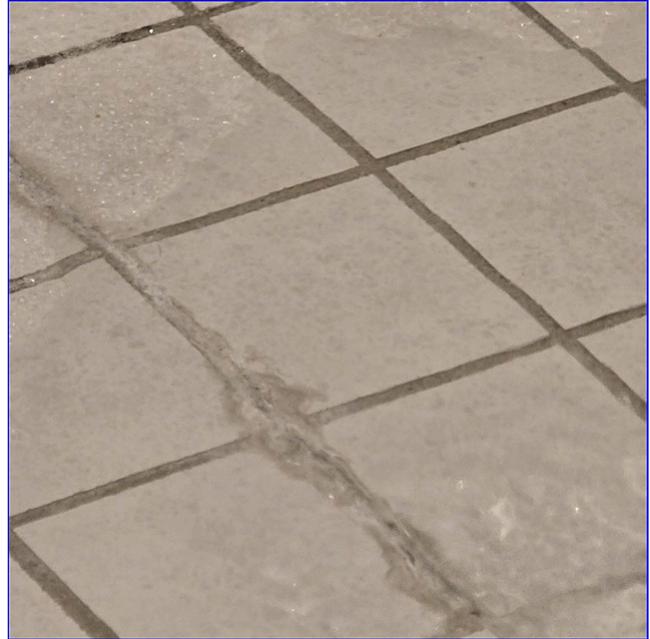
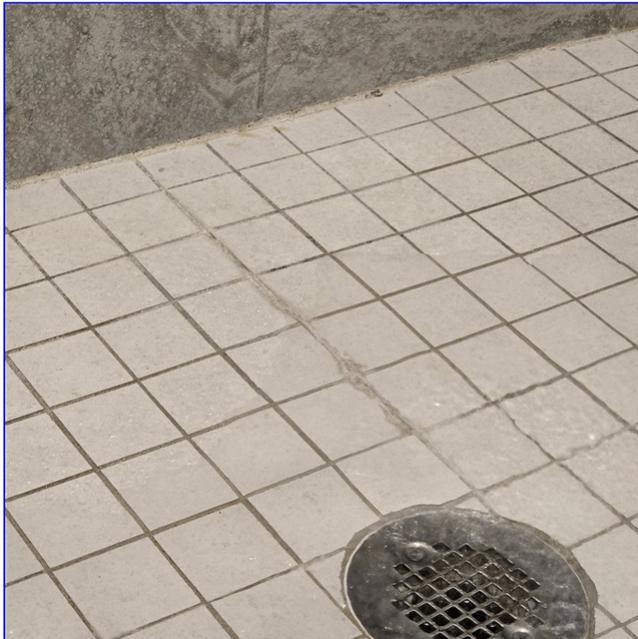
(2) The shower pan had a line of sealant applied along a mortar joint, indicating a past repair. The utility room below was locked, which limited evaluation of this area. Further evaluation is recommended to ensure there are no active leaks or concealed damage.
