Inspection Report

Property Address:
75 West Amazing Life Steet
Near the Beach NJ 08540

Master Building Inspections

Property Address 75 West Amazing Life Steet Near the Beach NJ 08540	Date of Inspection 3/17/2026	Report ID 202603283341-1930-2300
Customer(s) Susan Green	Time of Inspection 10:30 AM	Real Estate Agent

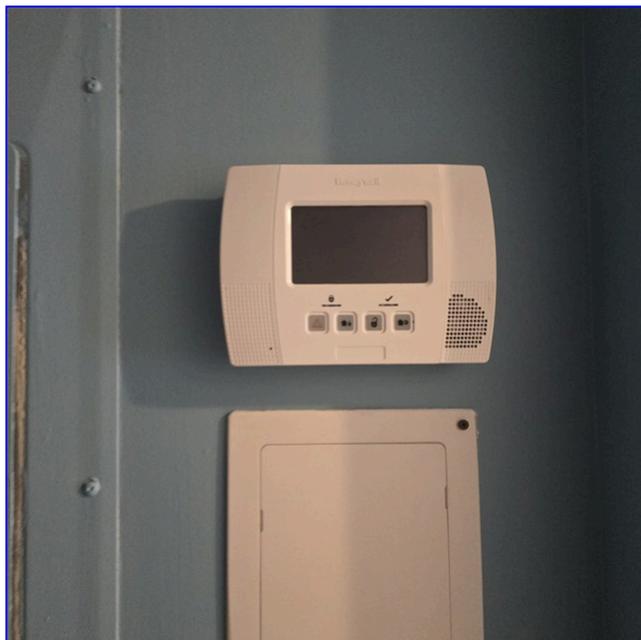
8.6 Item 1 (Picture)

The security system is outside the scope of the home inspection. I suggest contacting the seller or having the system fully evaluated by a home security specialist.

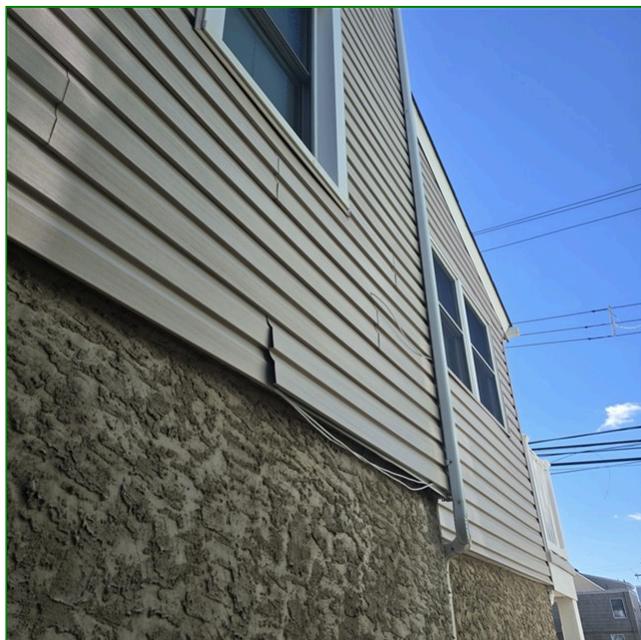
1.0 Item 1 (Picture)

One section of vinyl siding on the side of the home was observed to be loose. Repair as needed to ensure proper attachment and to help prevent moisture intrusion and wind damage.

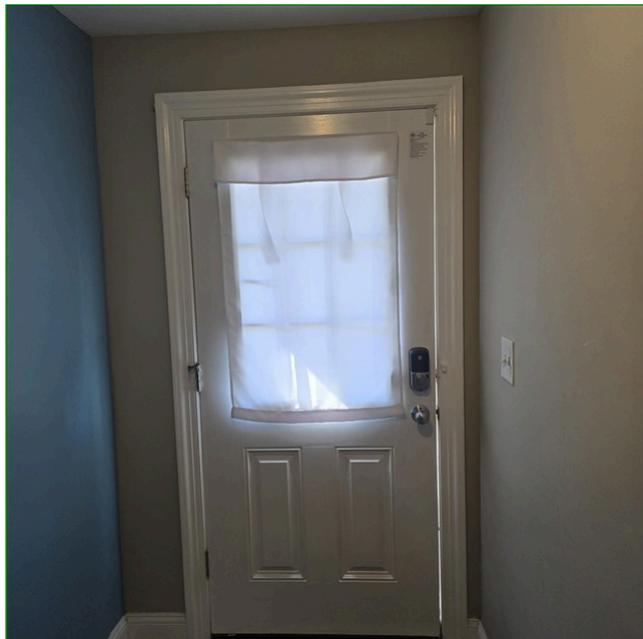
1.1 Item 1 (Picture)

(1) Areas of the front door weatherstripping is damaged and/or missing. This can allow for loss of homes conditioned air increasing electric and gas bills. I recommend having a qualified contractor repair/replace damaged areas

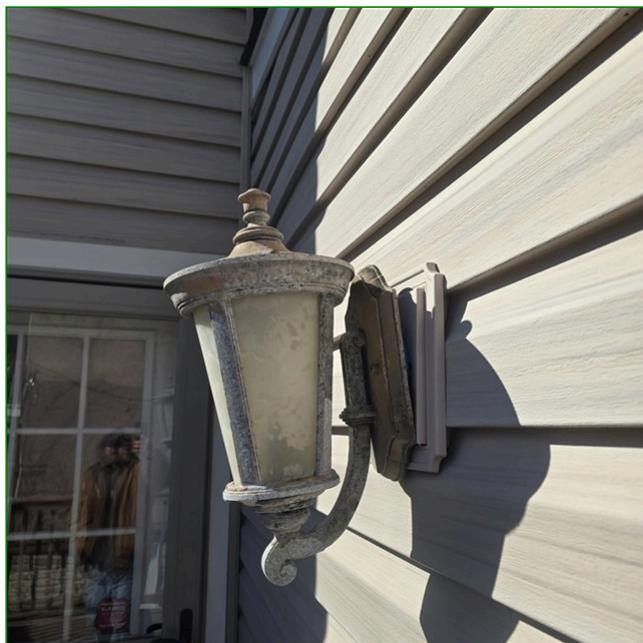
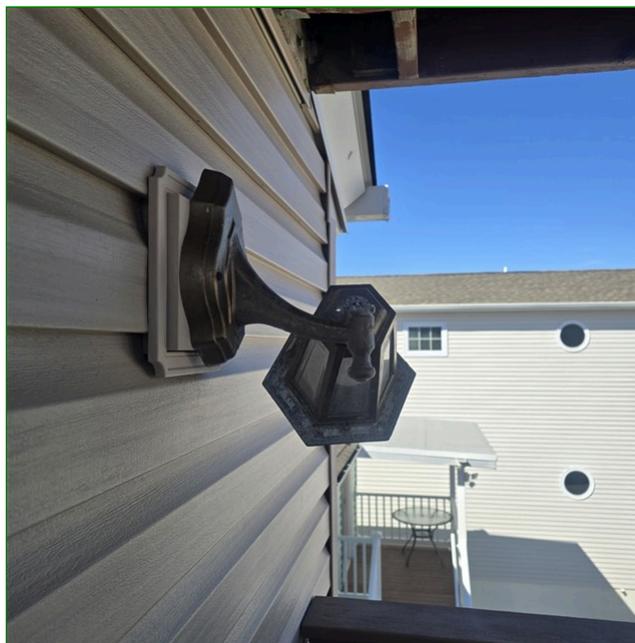
(1) Two exterior light fixtures were observed to be loose and hanging from the wall. Repair or secure as needed to ensure proper mounting and safe operation.

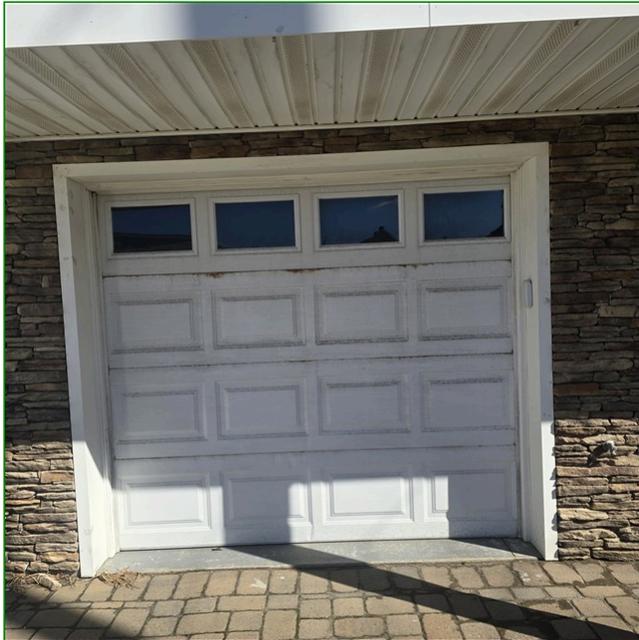
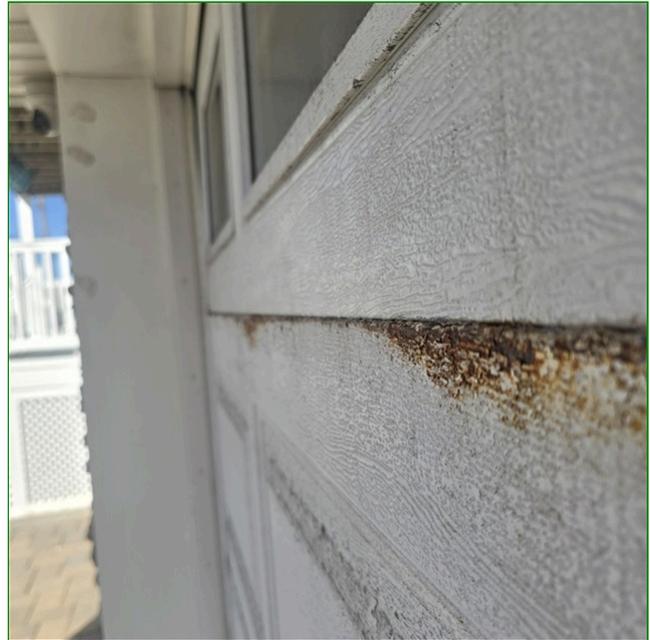
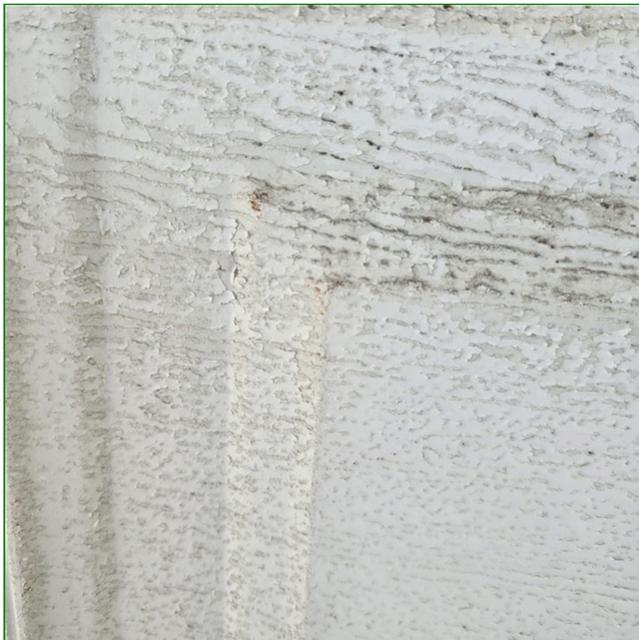
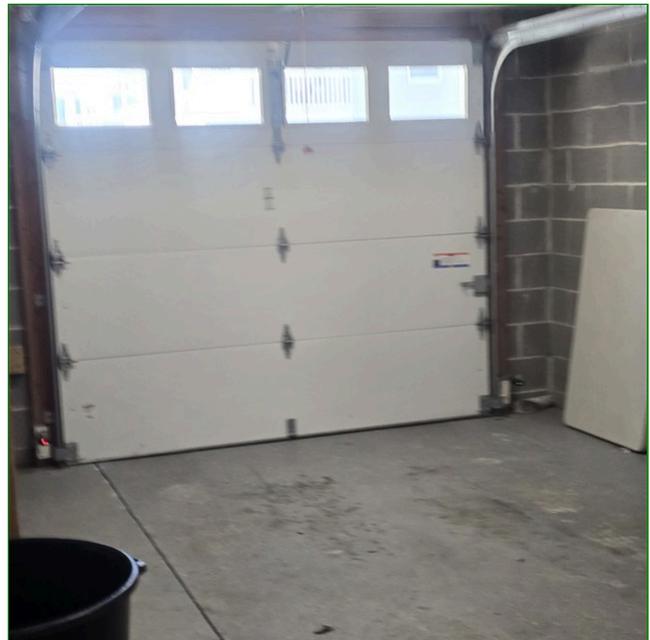
The metal garage door exhibited areas of rust and corrosion. Flaking paint was also observed and may contain lead. Have the door further evaluated and repainted to help prevent further deterioration and prolong its serviceable life. Use caution when disturbing painted surfaces.
